West Coast Salmon Summit

Leo Kuntz
Tidegate Specialist
Nehalem Marine Manufacturing
Nehalem, Oregon

May 16- 17, 2013

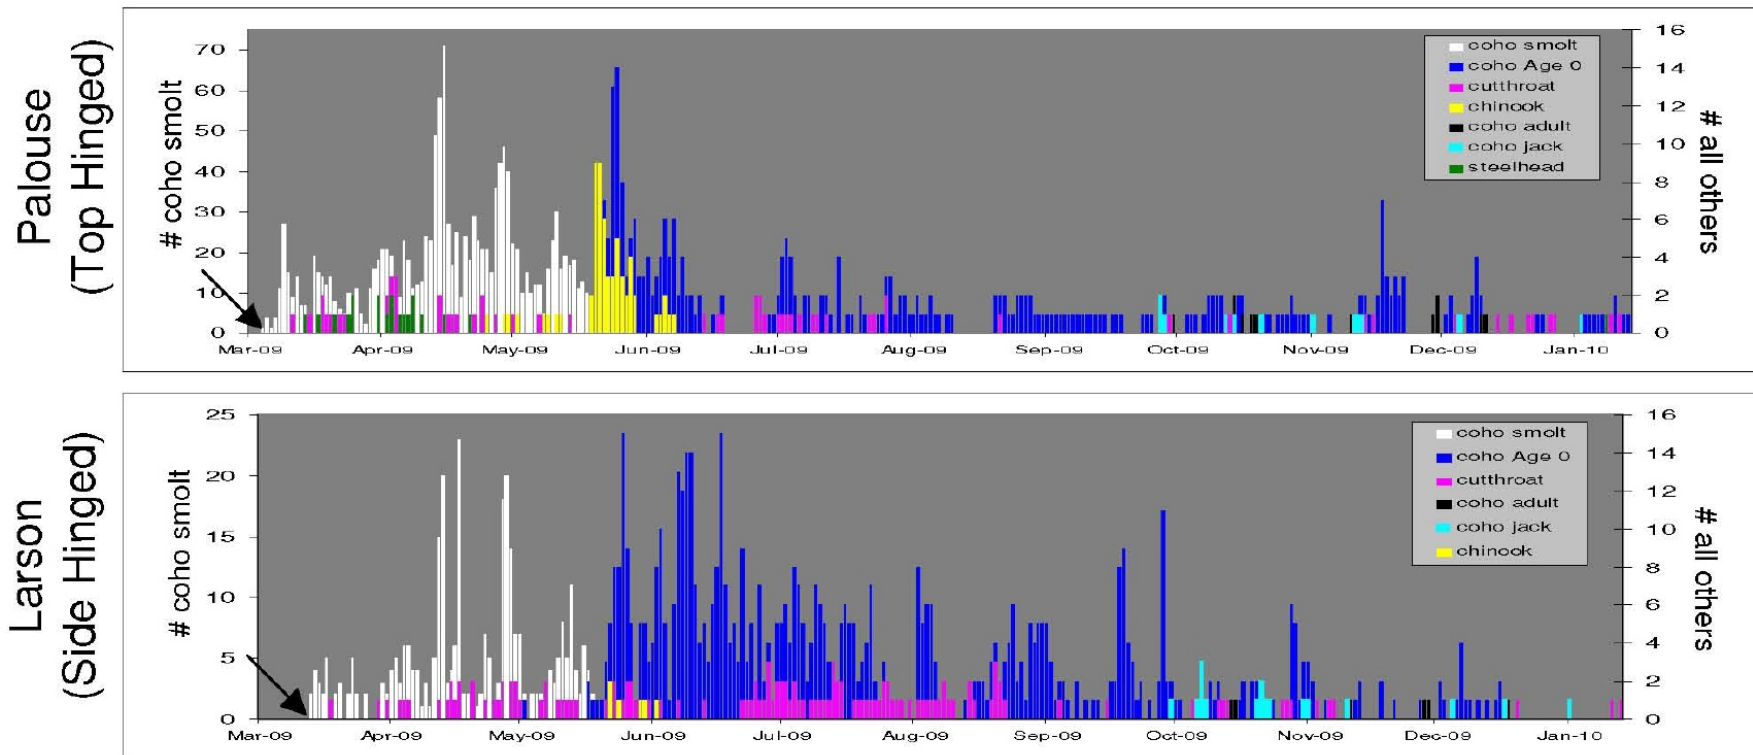
Salmonid Presence at all Sites

Graphs of fish movement through tidegates at Coos Bay, OR

(Credits: Arthur Bass, Guillermo Giannico, Coos Watershed & OSY)

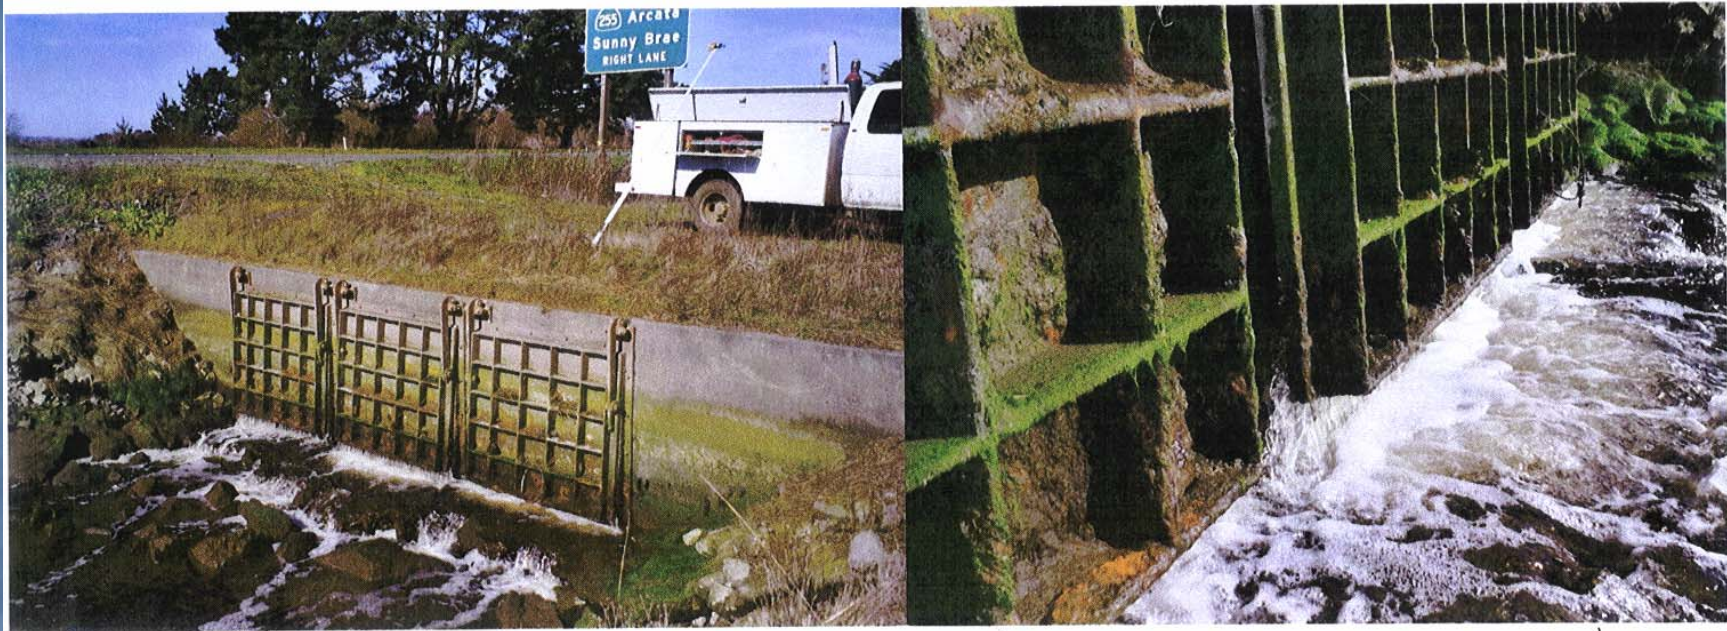
A Tidegate System From the Past

The old Cast Iron tide gate system were extremely poor for both fish passage and conveyance because the weight to size ratio is extremely high.

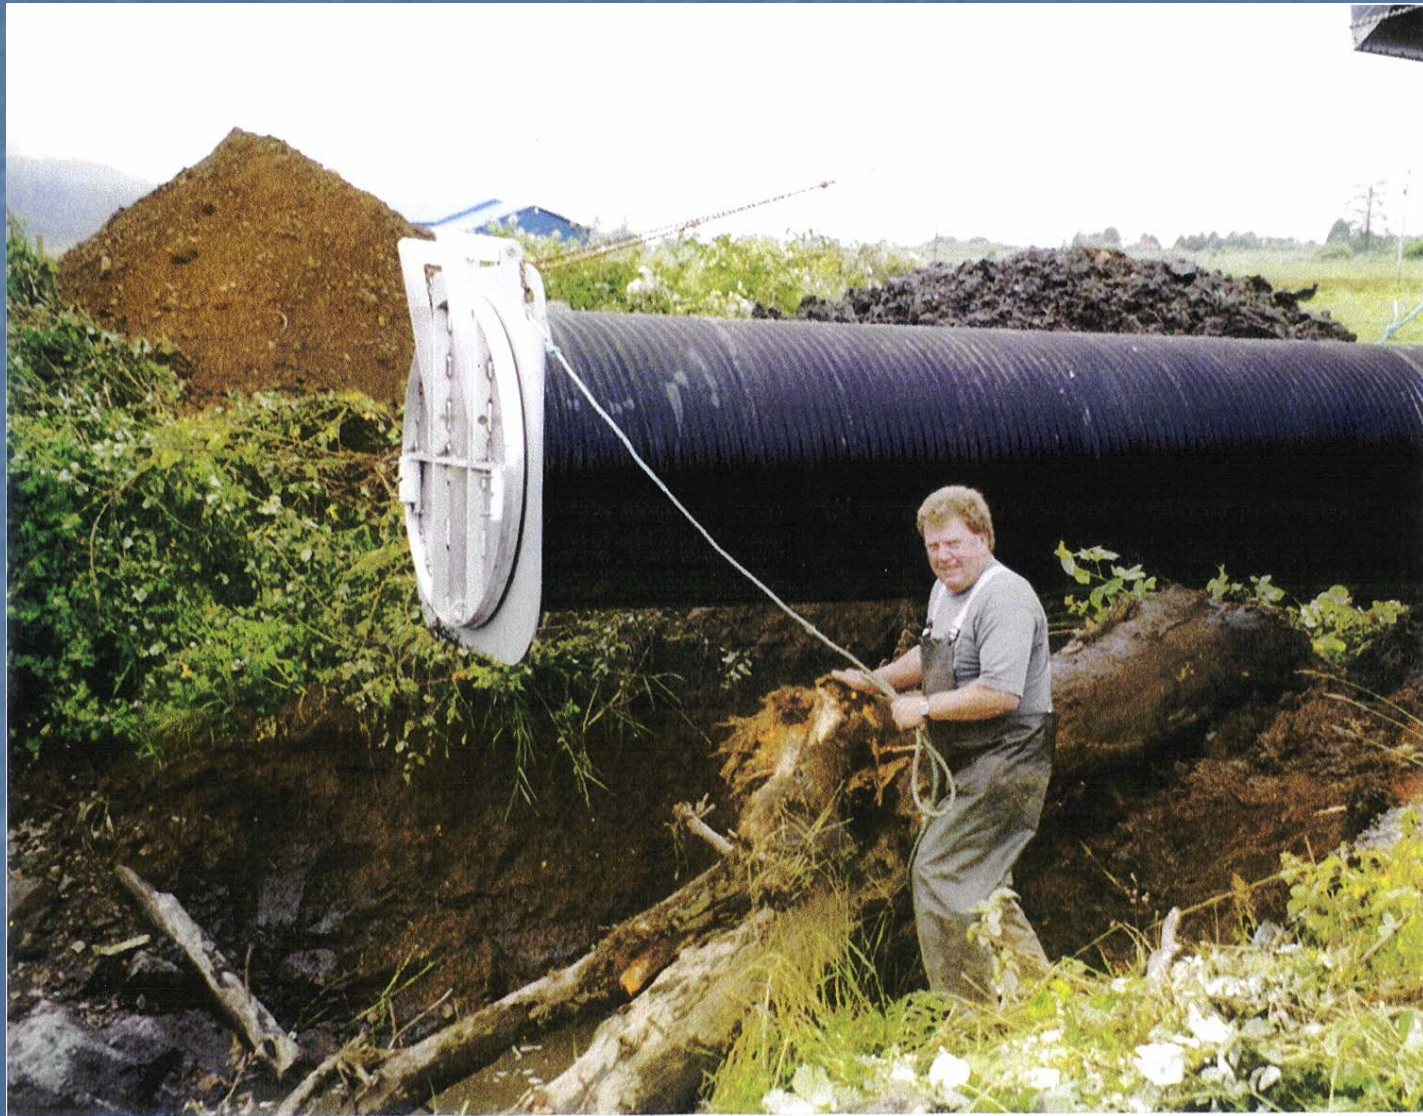
One of our early lightweight aluminum tidegates.
(Pictured: Don Reynolds, Tillamook Bay NEP 1998)

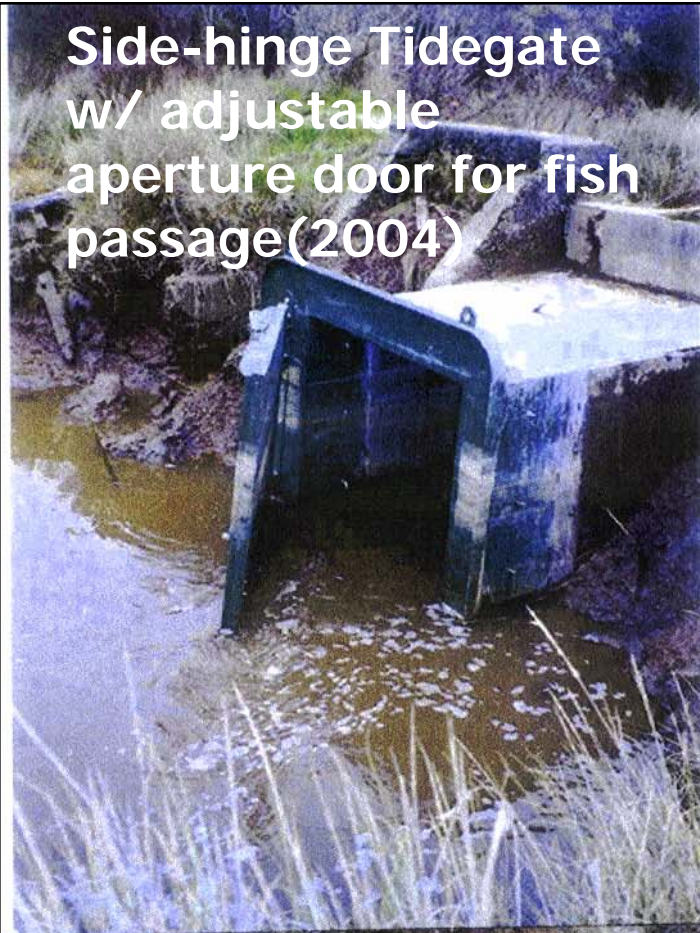
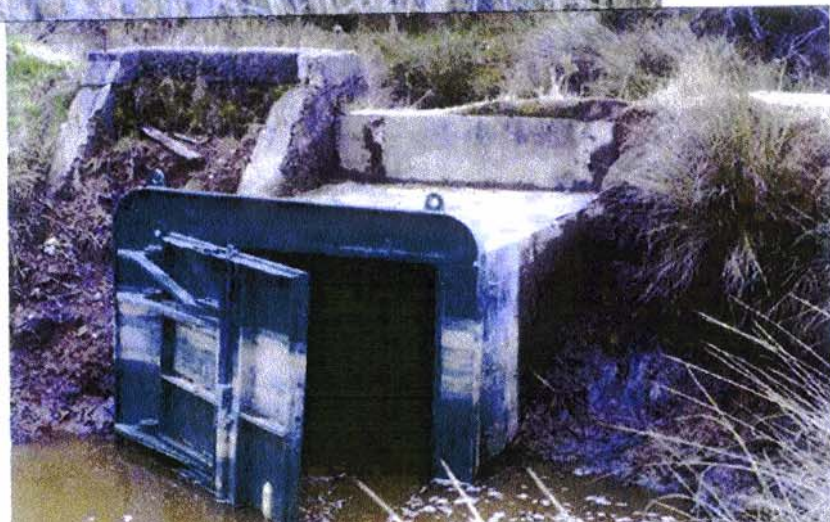
Coalbank Tide Gates
Coos Bay, Oregon

Side-hinge Tidegate
w/ adjustable
aperture door for fish
passage(2004)

*Tool- Adjustable Aperture Auxiliary Door

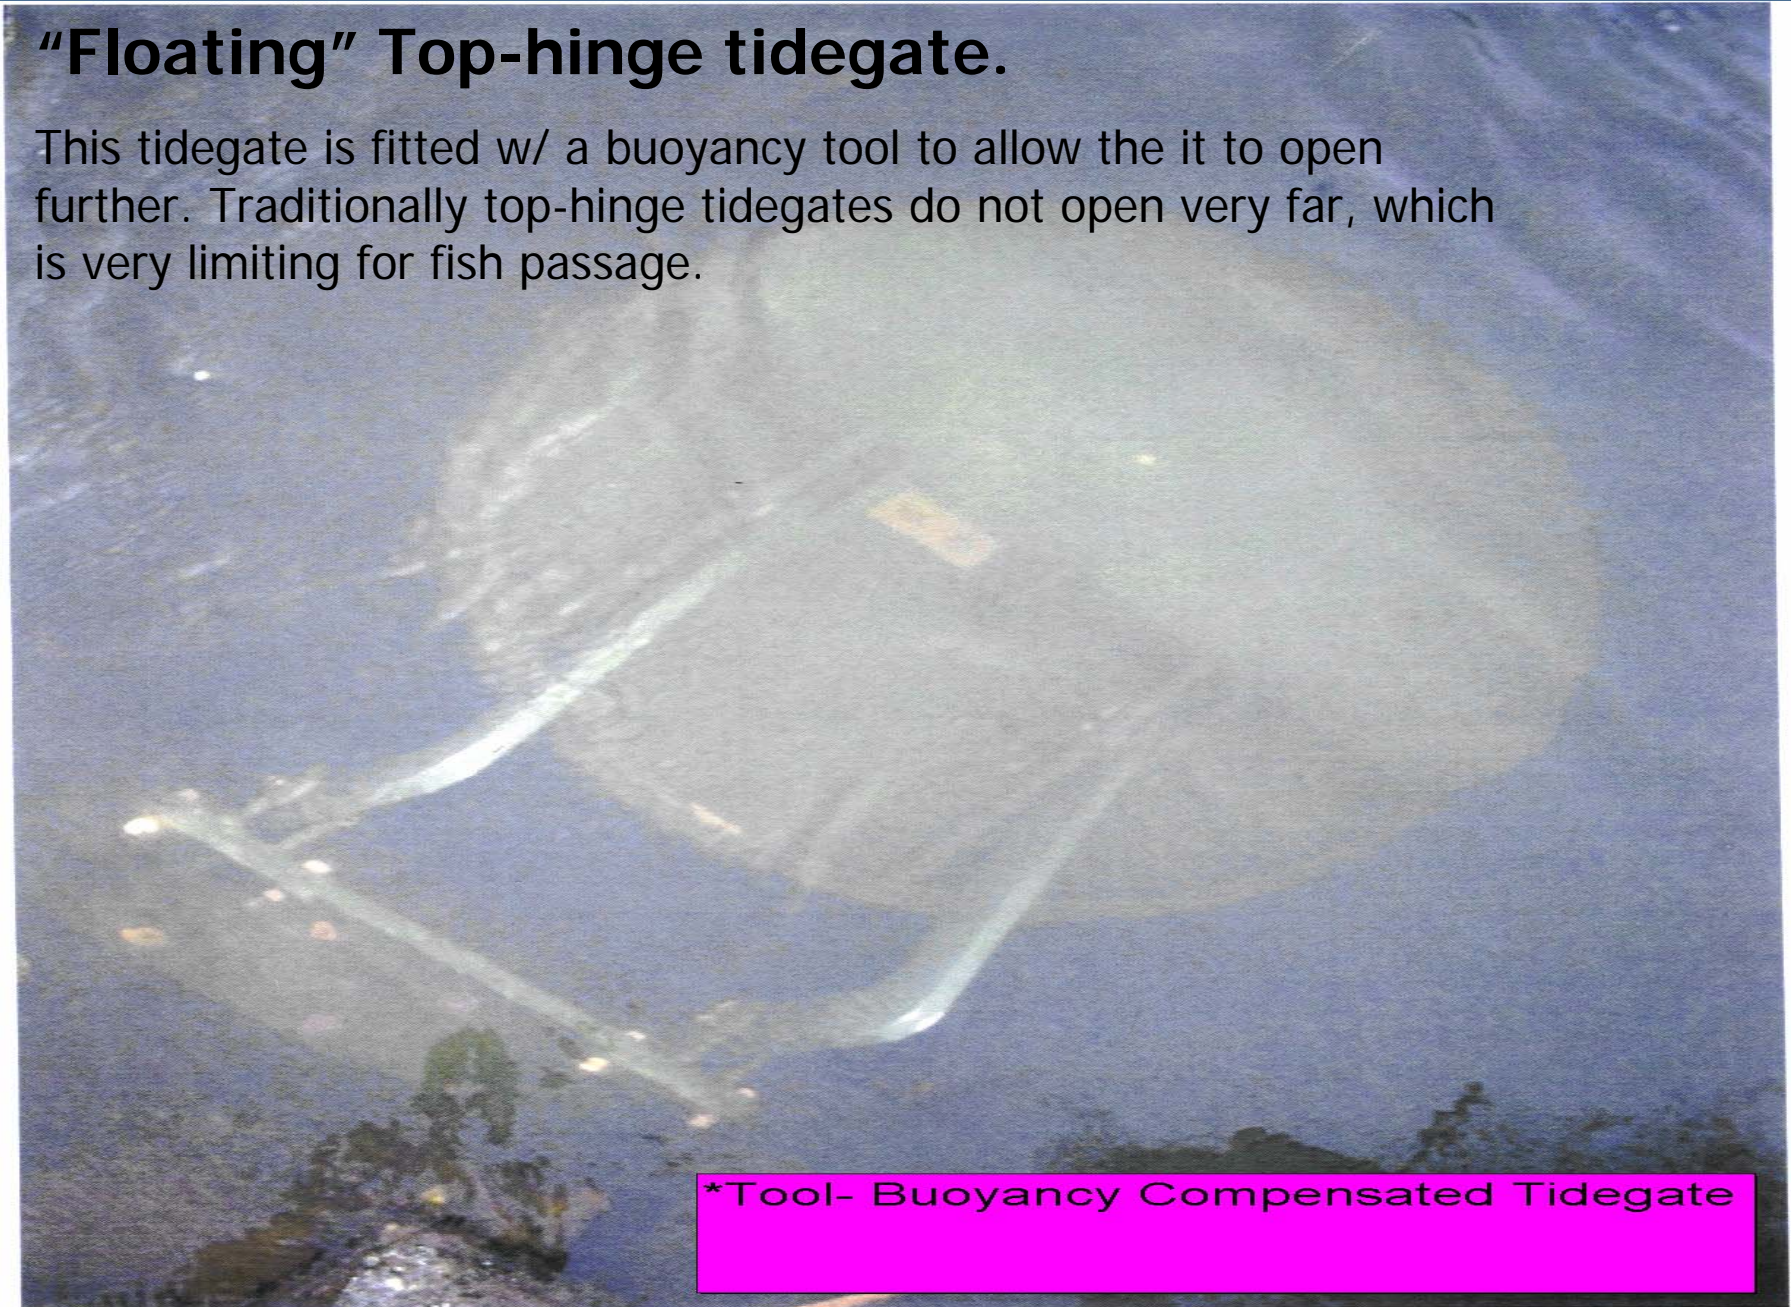
"Floating" Top-hinge tidegate.

This tidegate is fitted w/ a buoyancy tool to allow the it to open further. Traditionally top-hinge tidegates do not open very far, which is very limiting for fish passage.

***Tool- Buoyancy Compensated Tidegate**

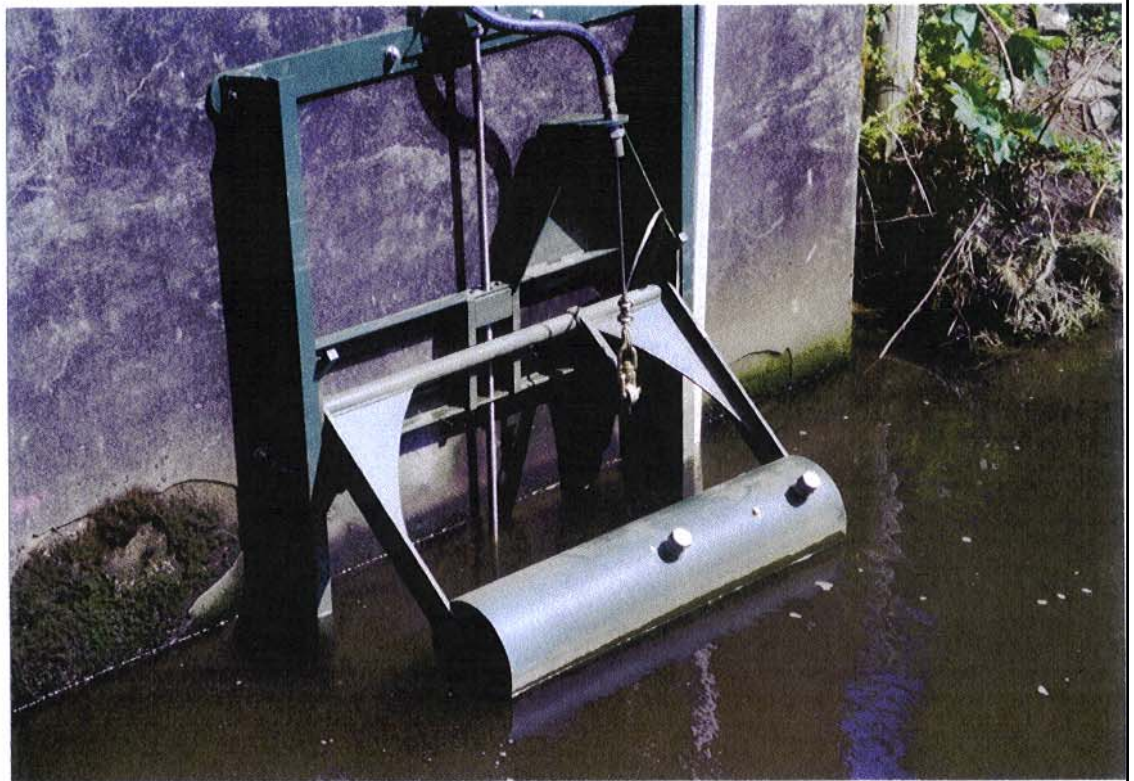
Mid Ebb Tide

****Tool- Muted Tidal Regulator***

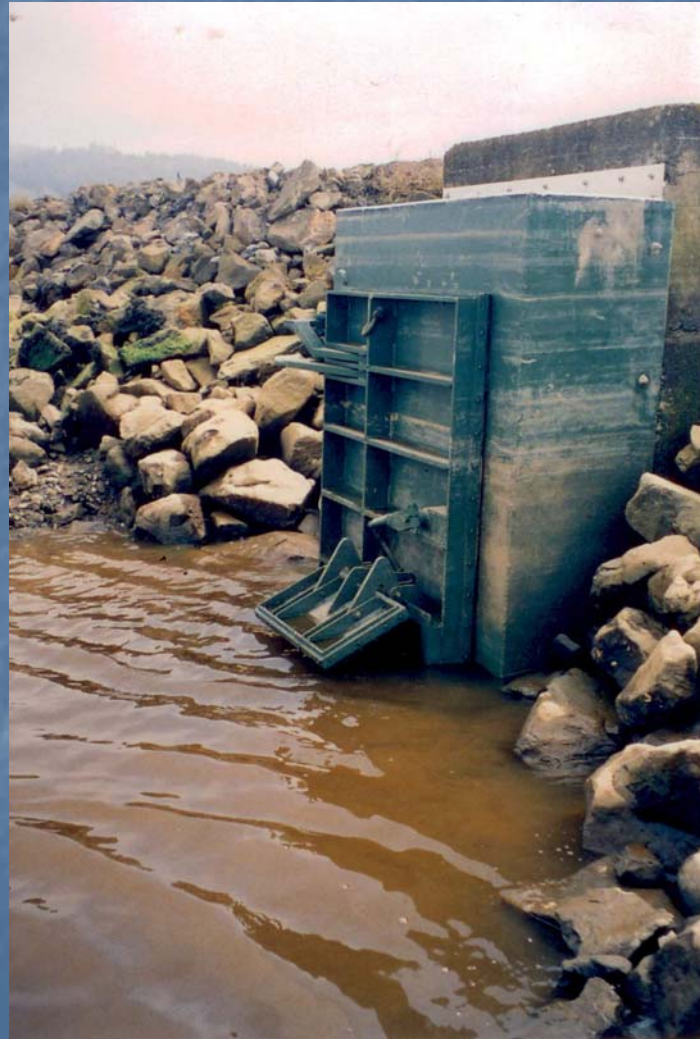
MTR Controlled Auxiliary Door

Location: USFW
Humboldt Bay
National Wildlife
Refuge

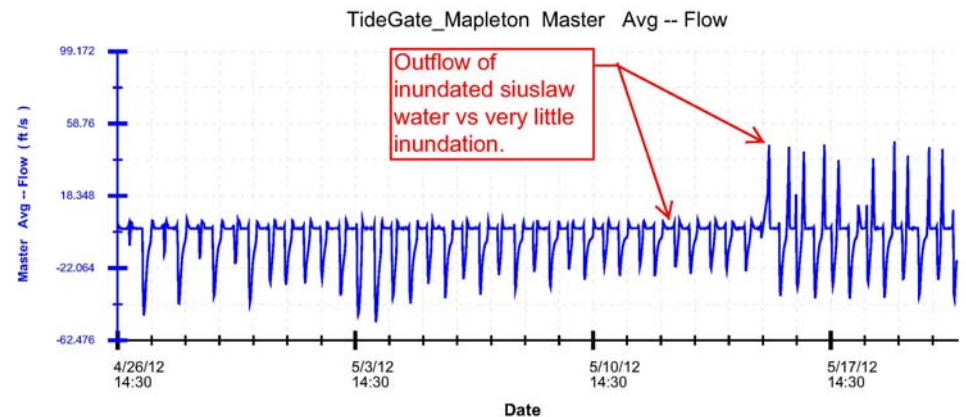
These graphs are a great data collection of a side-hinge gate operating w/out a regulator then the same gate operating with a regulator. As the data is a direct comparison (same gate, same waterway) it is very telling.

We obtained this data as the MTR for this gate was unhooked for modifications (beginning of graphs) then re-activated (end of graphs)

(Pheylane tidegate.
Slides from Ryan
McCormick ODFW)

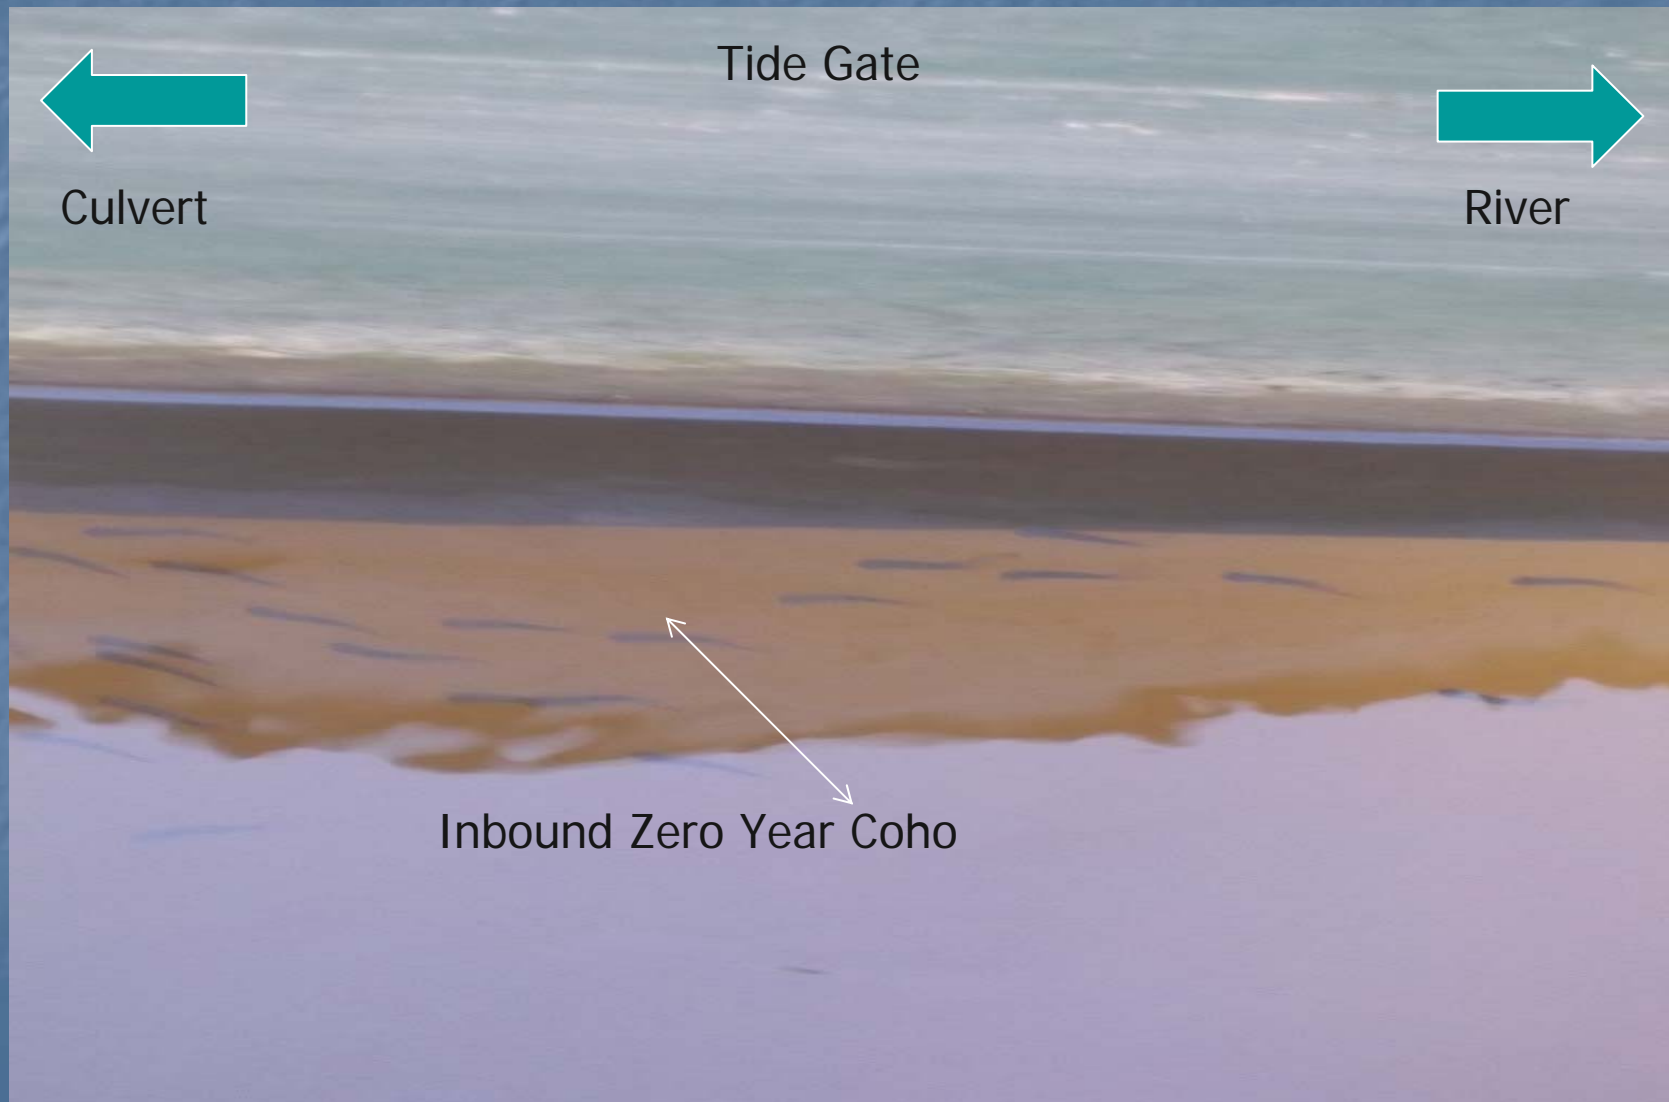
Fish Passage @ Pheylane

Coho entering OCTH through MTR side-hinge tidegate. They are presumed to be from upper Siuslaw Watershed and seeking OCTH.

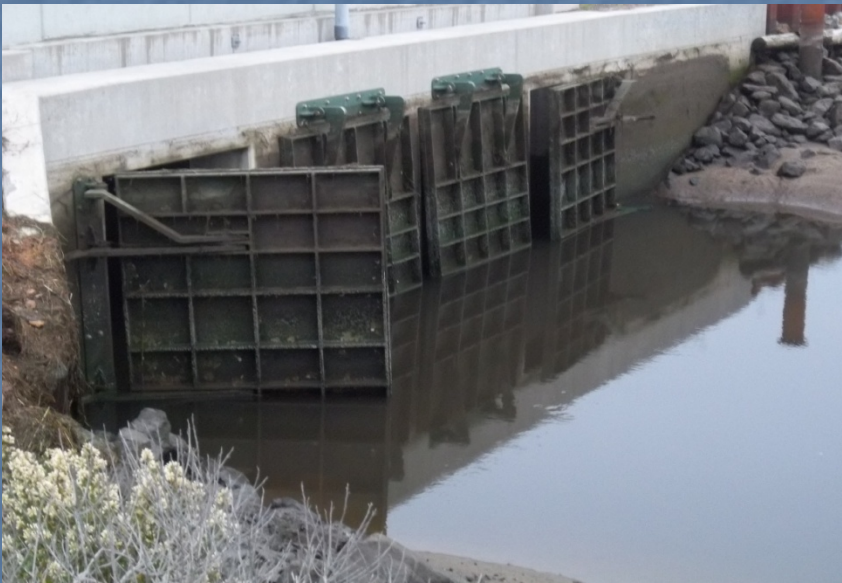
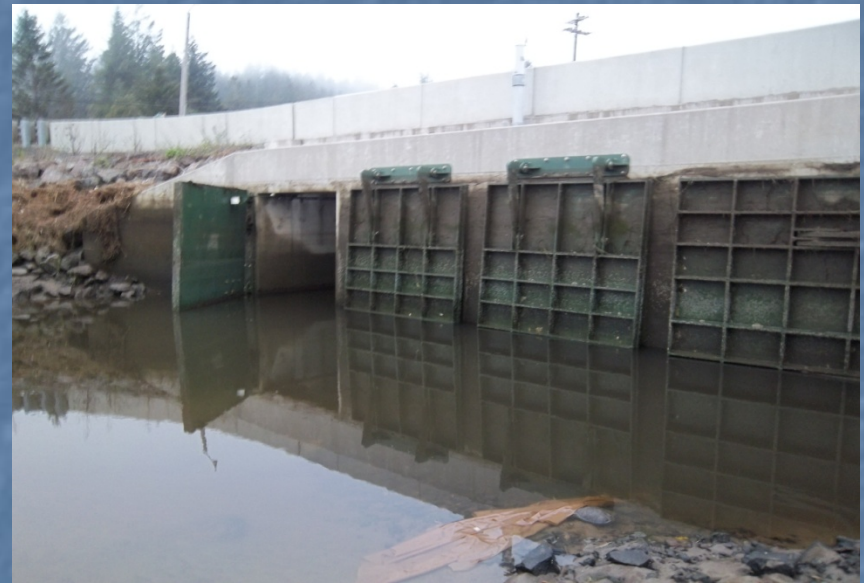
Kentuck Tidegates

Early MTR system. Kentuck Slough, Coos Bay for Coos County Roadway Dept. (site of electronic monitoring station installed early 2012)

Top Hinge Side Hinge Array with MTR

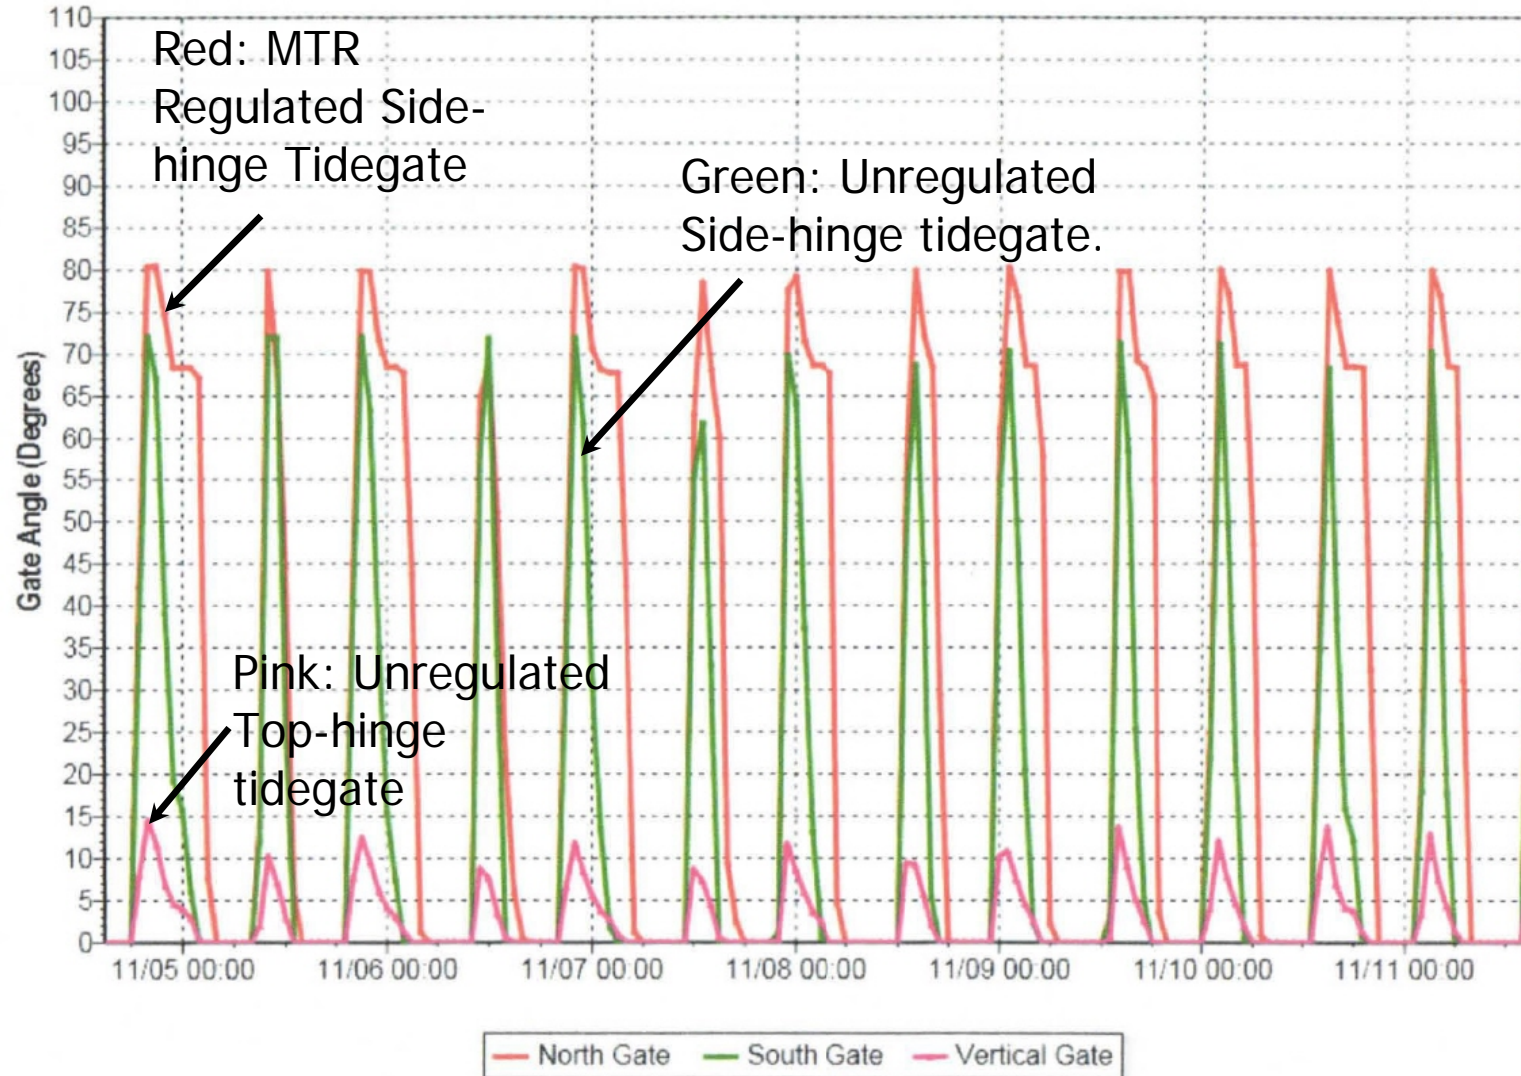
Kentuck Tidegates Monitoring Data

Kentuck Inlet

Graph showing how far the gates open.

Weekly Trend

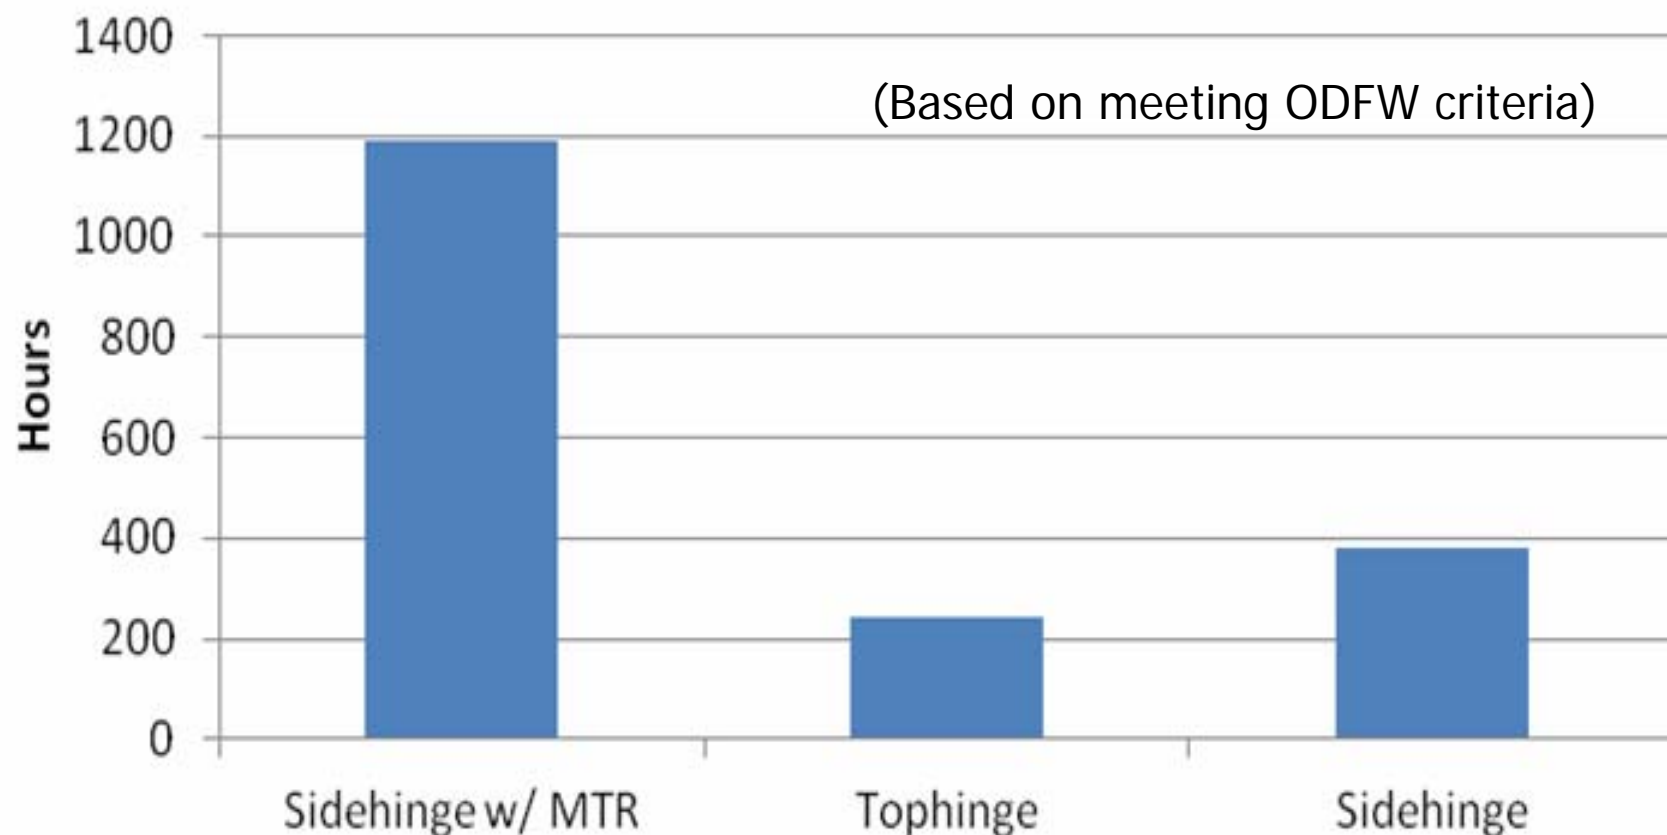
Kentuck Tidegates Monitoring Data

Fish Passage Time Hours from July 1 to October 31

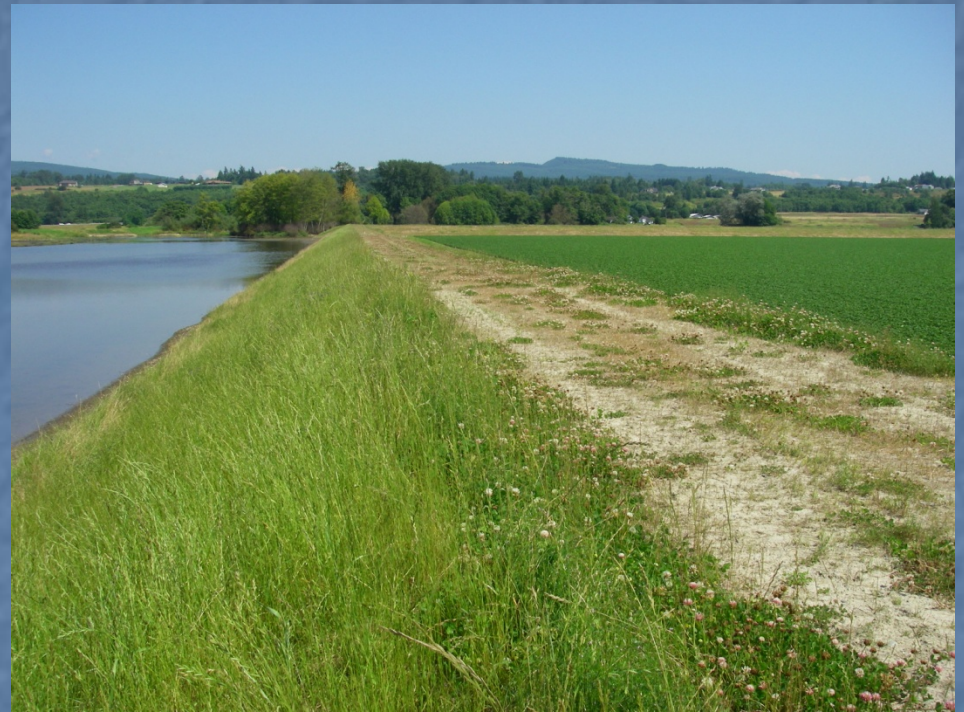
Fisher Slough Compatible Restoration

- This photo is intended to show restored/wet habitat adjacent to a growing commercial potato crop. This photo was taken as the water receded after three weeks of very high water in June and early July this year. The river had been near flood stage so the floodgates were closed much of the time and tributaries were also high. The dike and drainage measures we installed seemed to work great; the field was dry and the crop did fine. This was not the case in other fields in the delta.

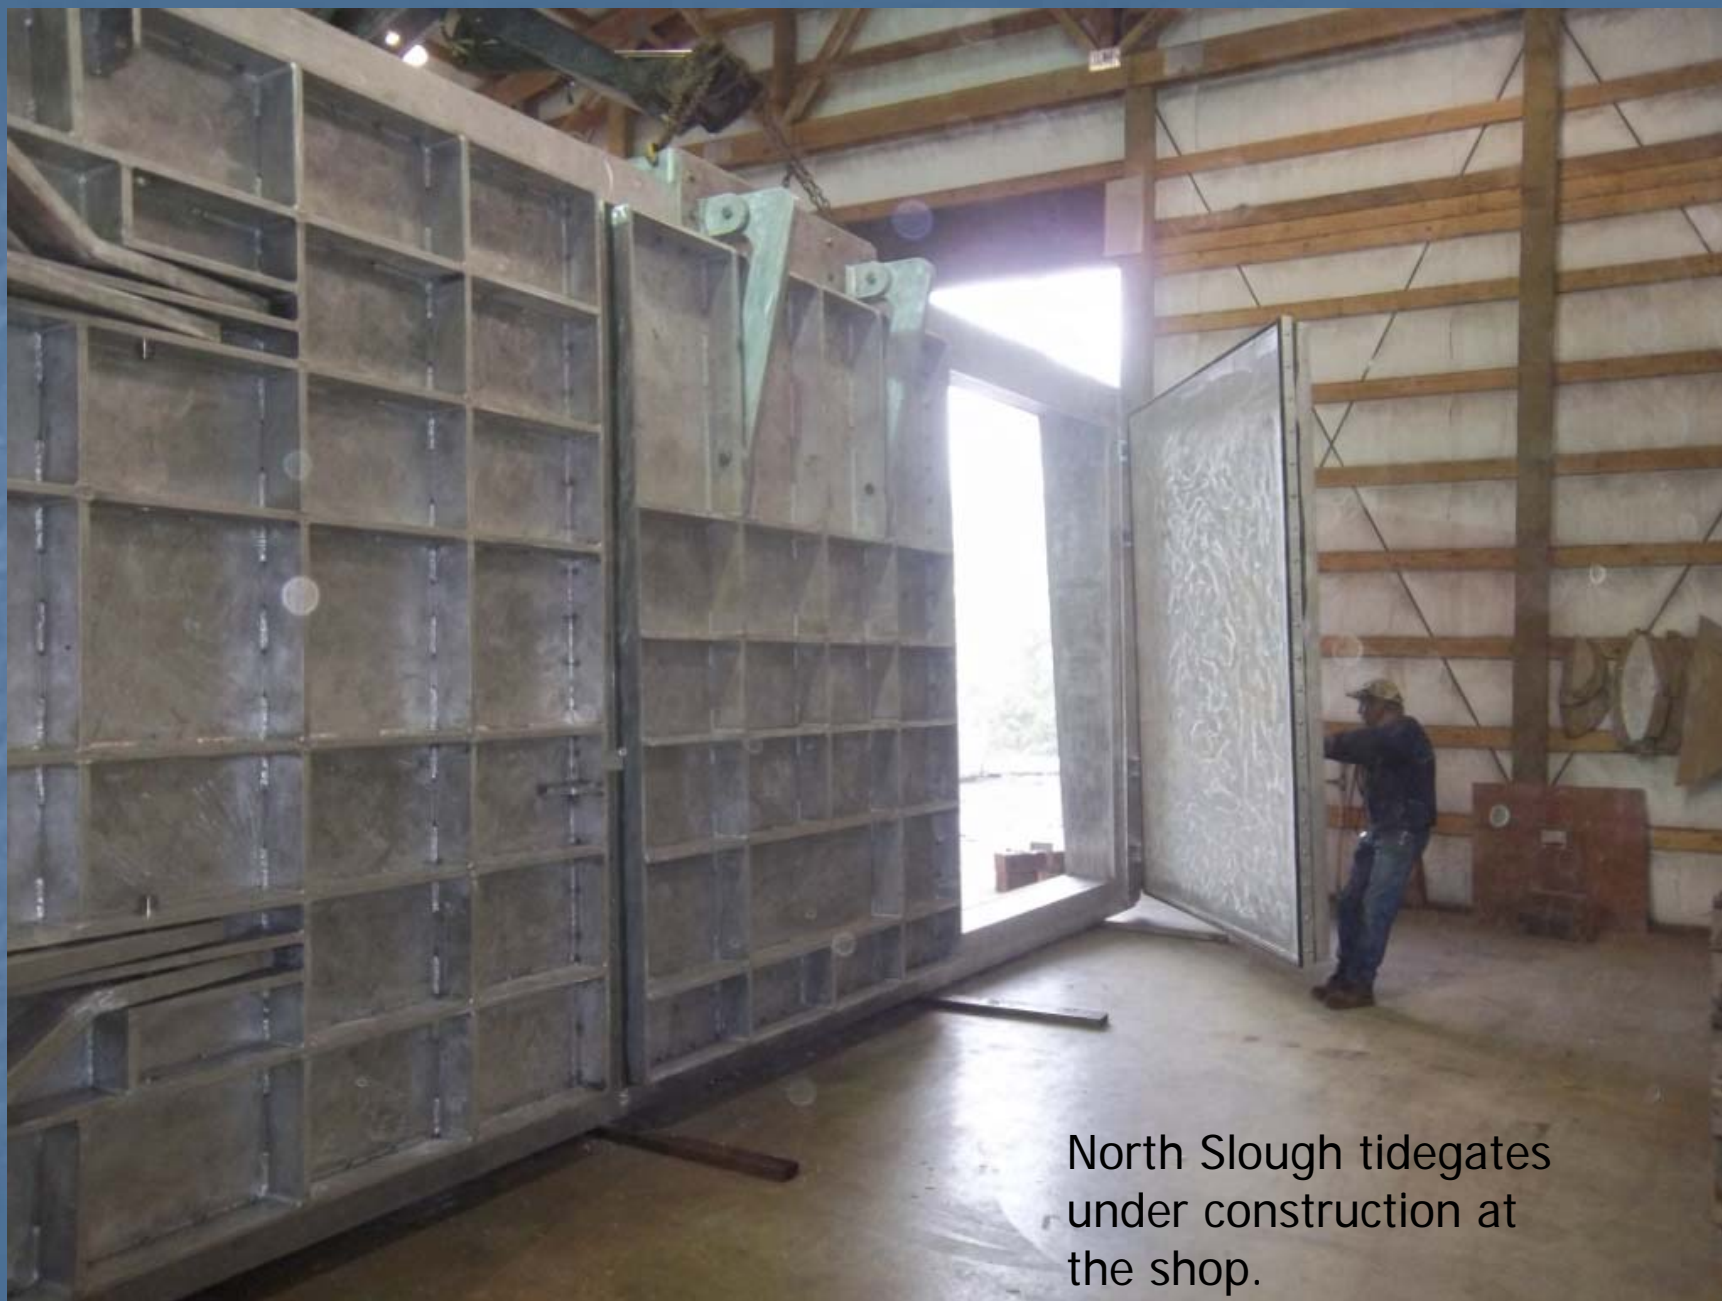
North Slough tidegates
under construction at
the shop.

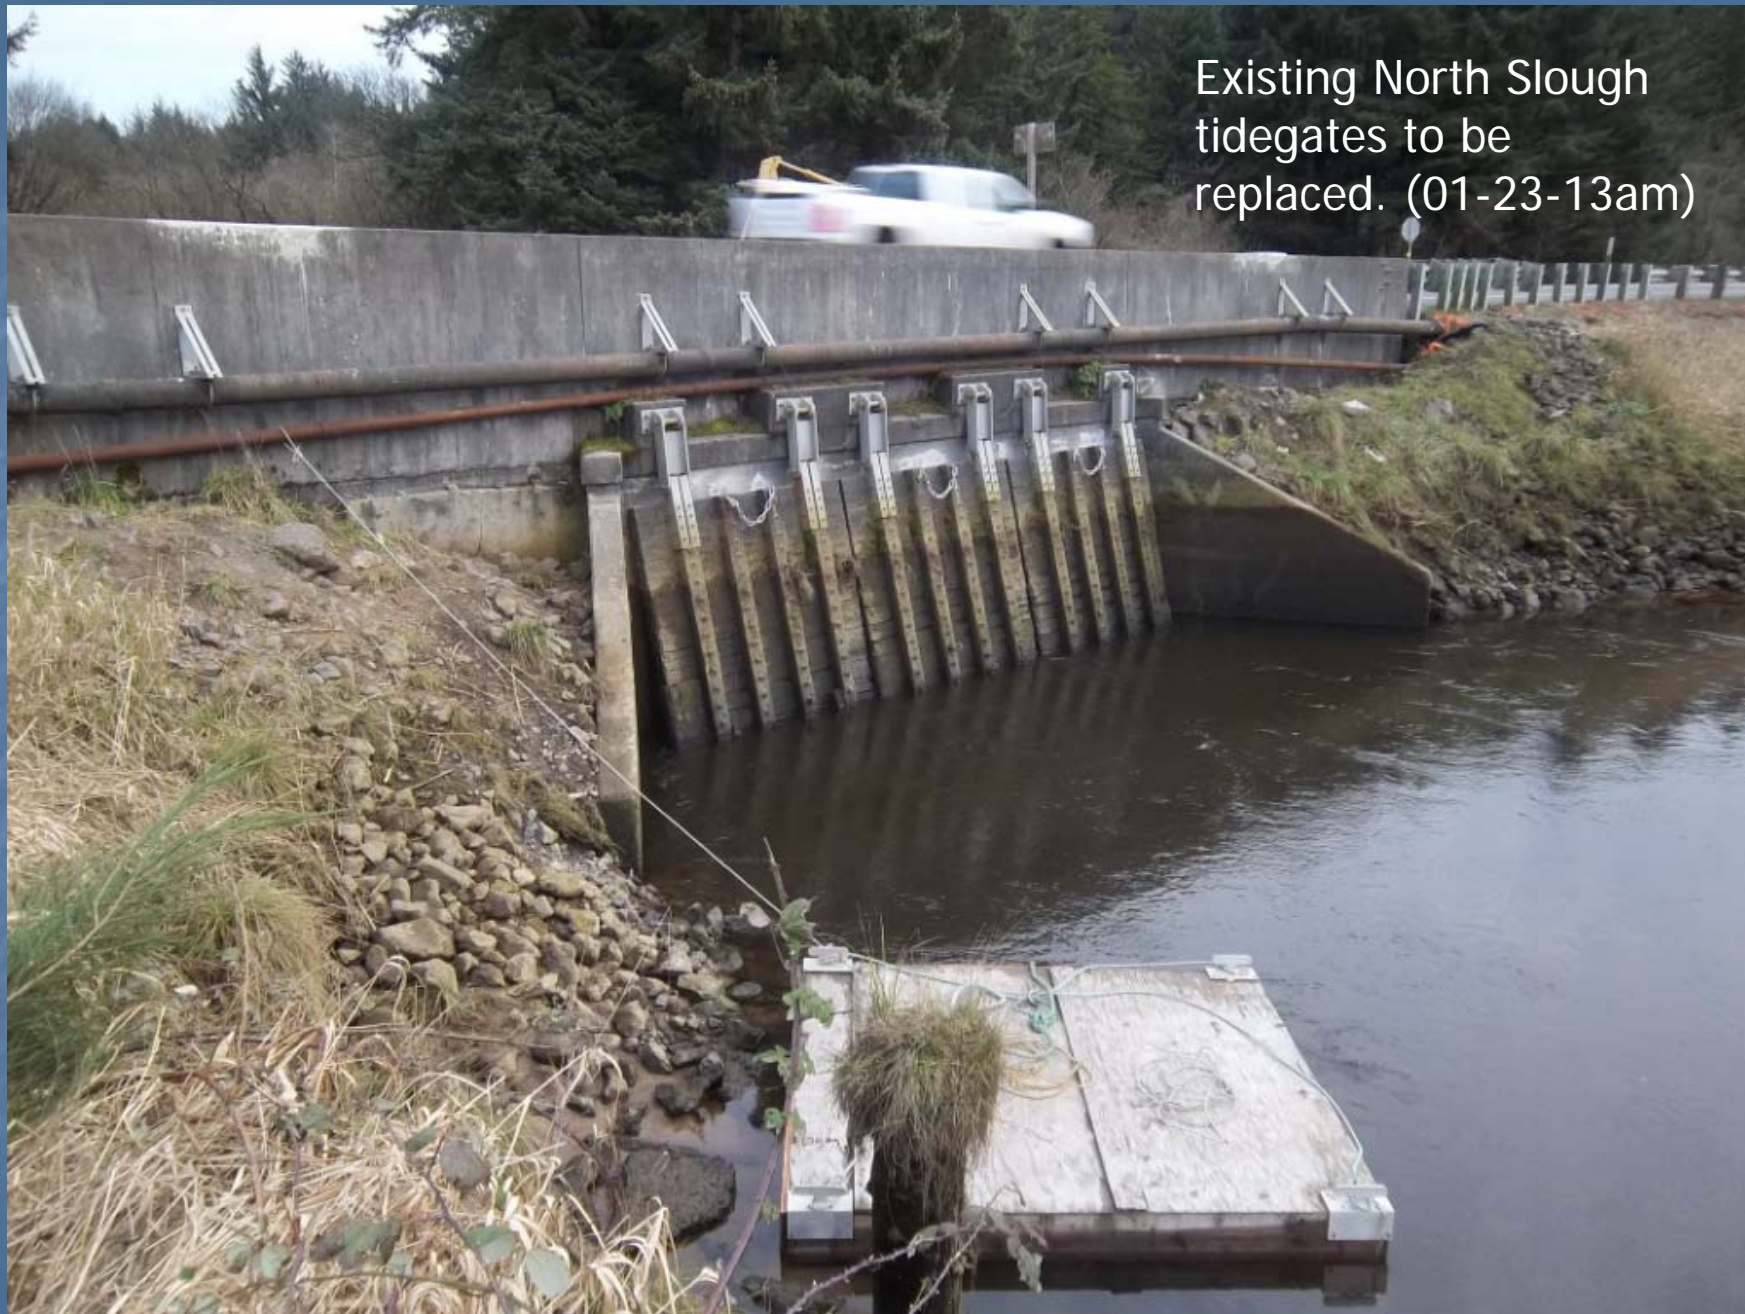
North Slough tidegate
replacement project
01/23/13 mid-day.
