West Coast Salmon Summit

Leo Kuntz
Tidegate Specialist
Nehalem Marine Manufacturing
Nehalem, Oregon

May 16- 17, 2013

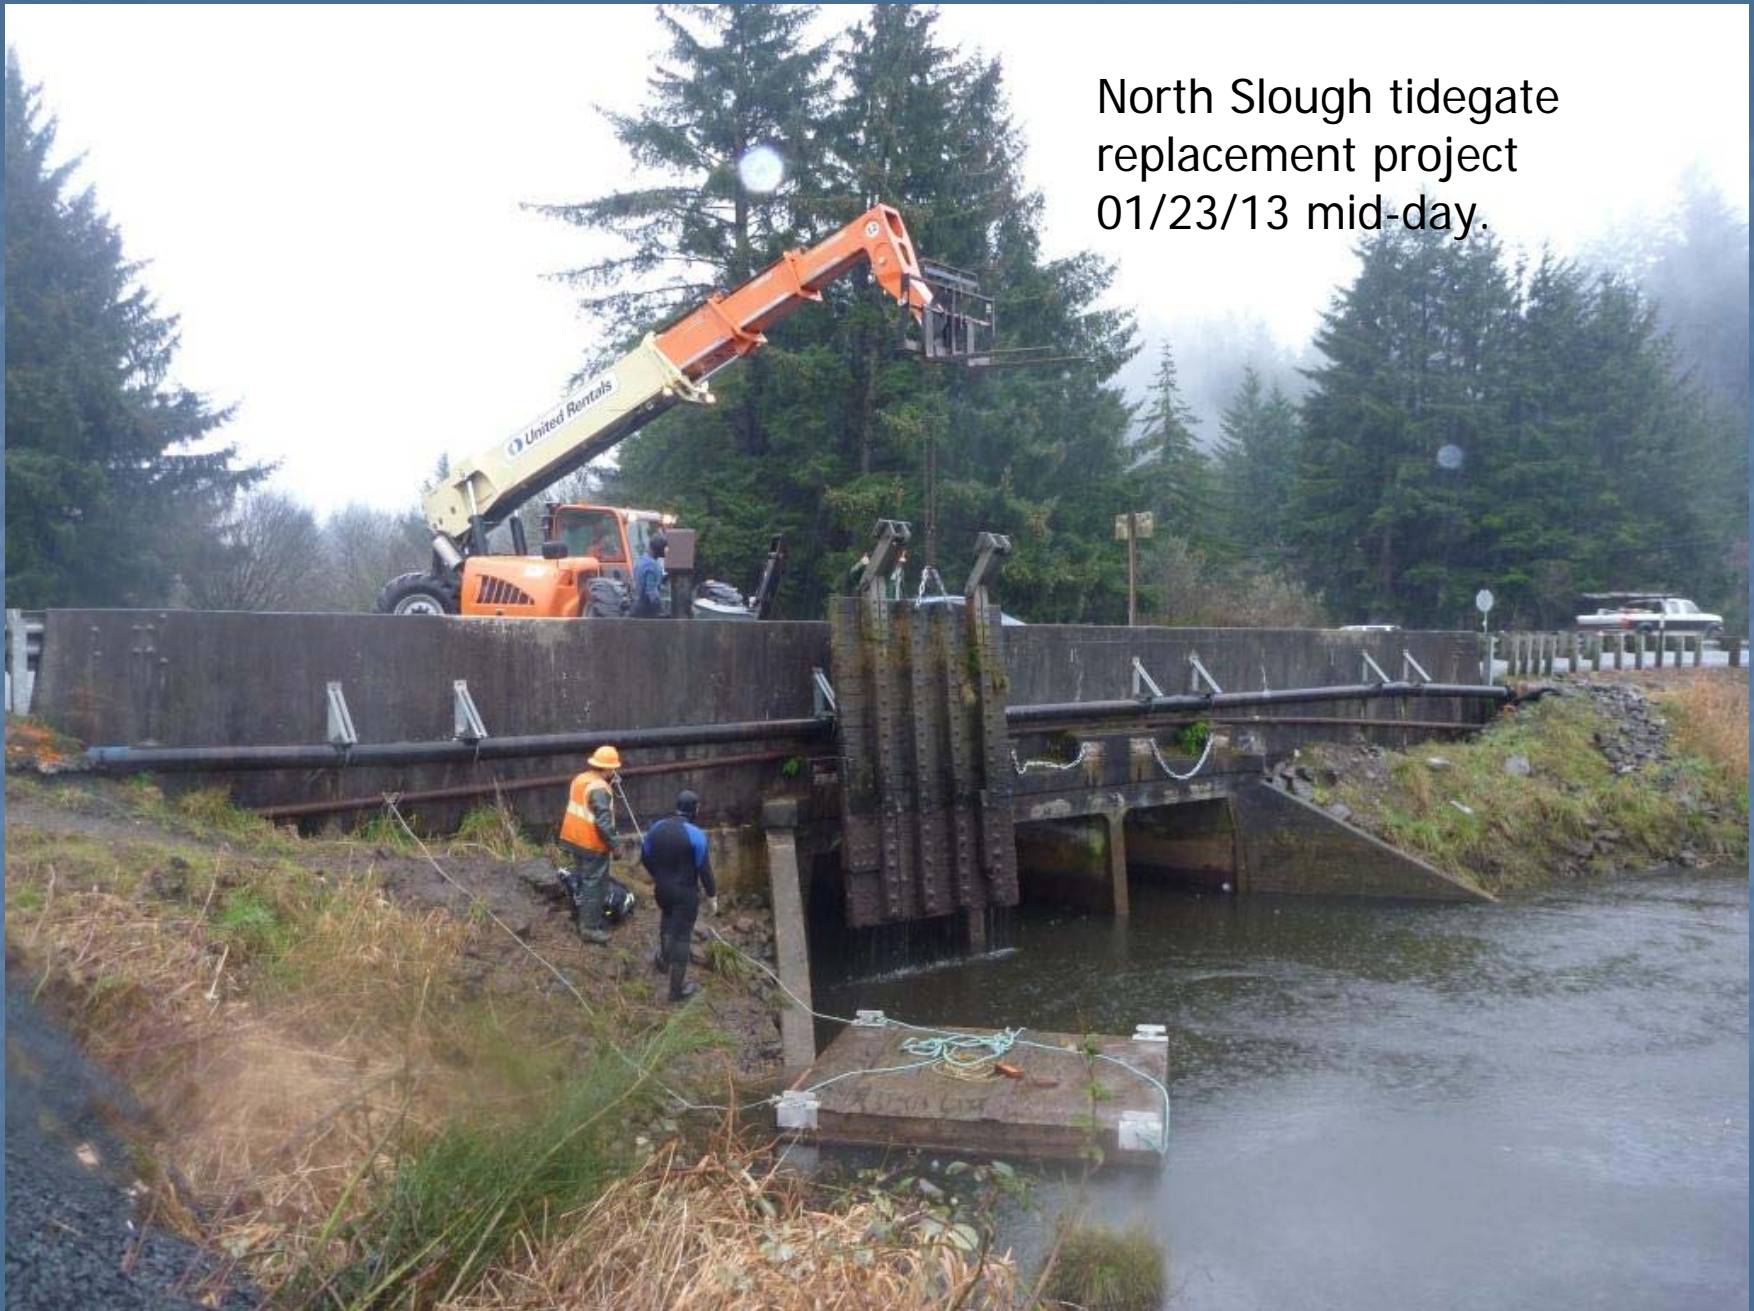
North Slough tidegate
replacement project
01/23/13 early
afternoon.

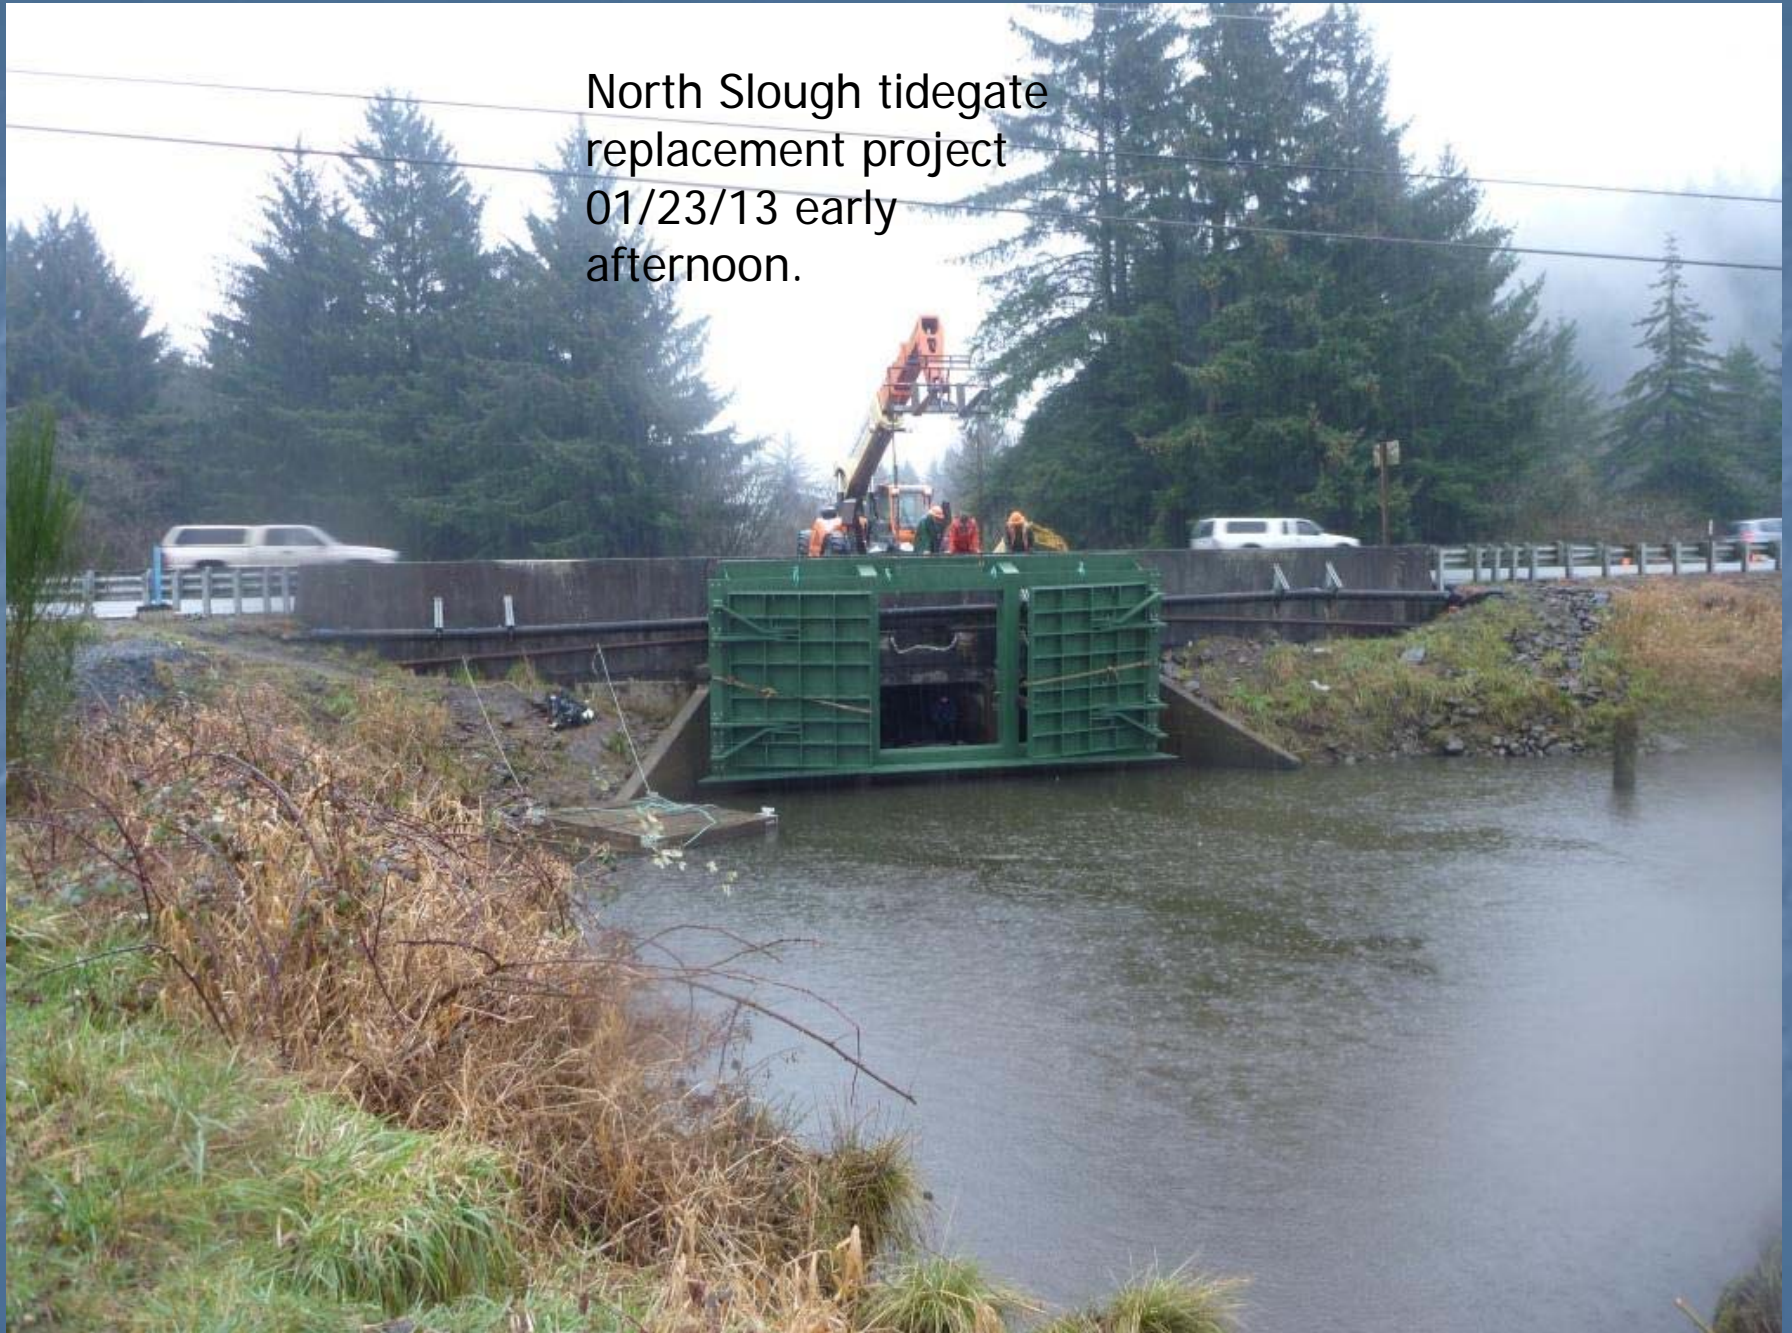
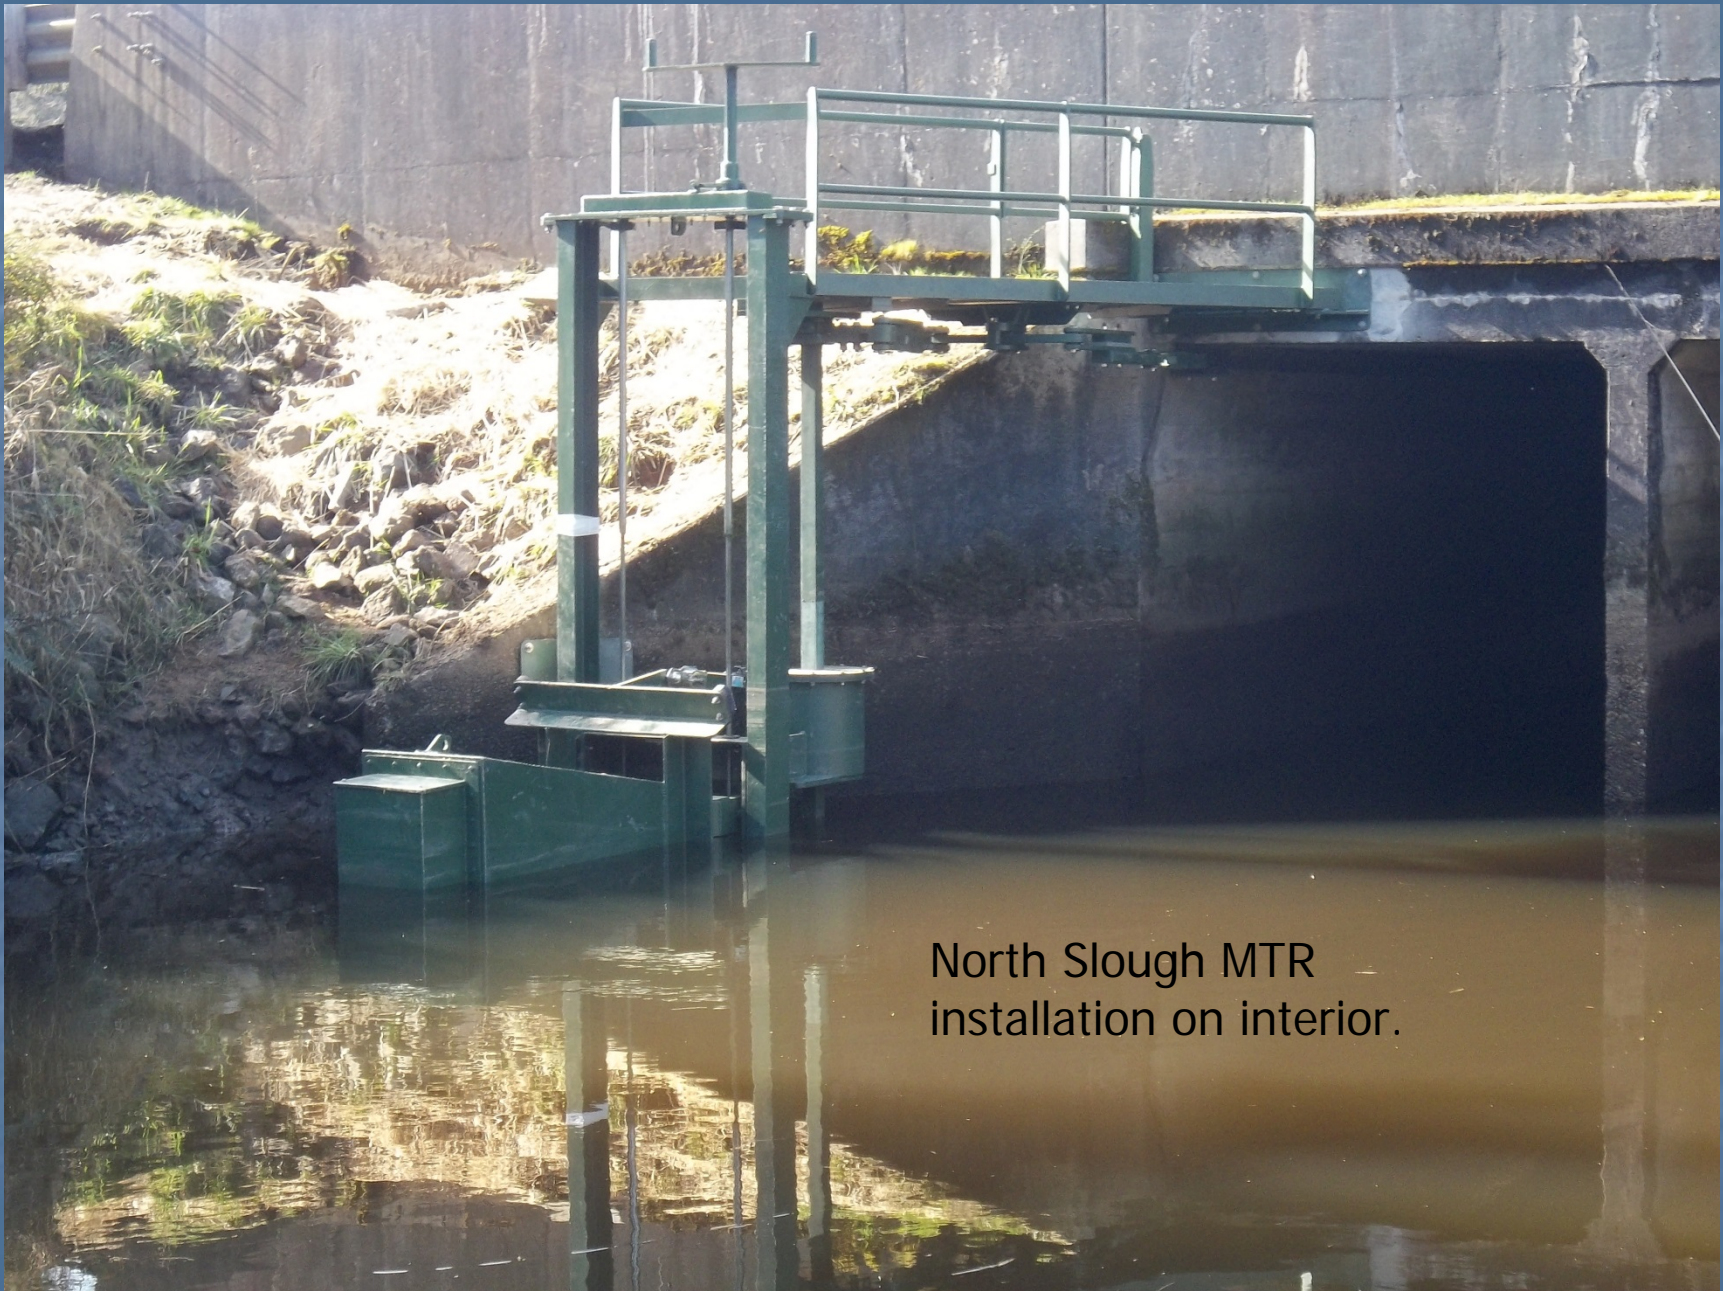
North Slough MTR
installation on interior.

North Slough 01/23/13
afternoon, operating
normally.

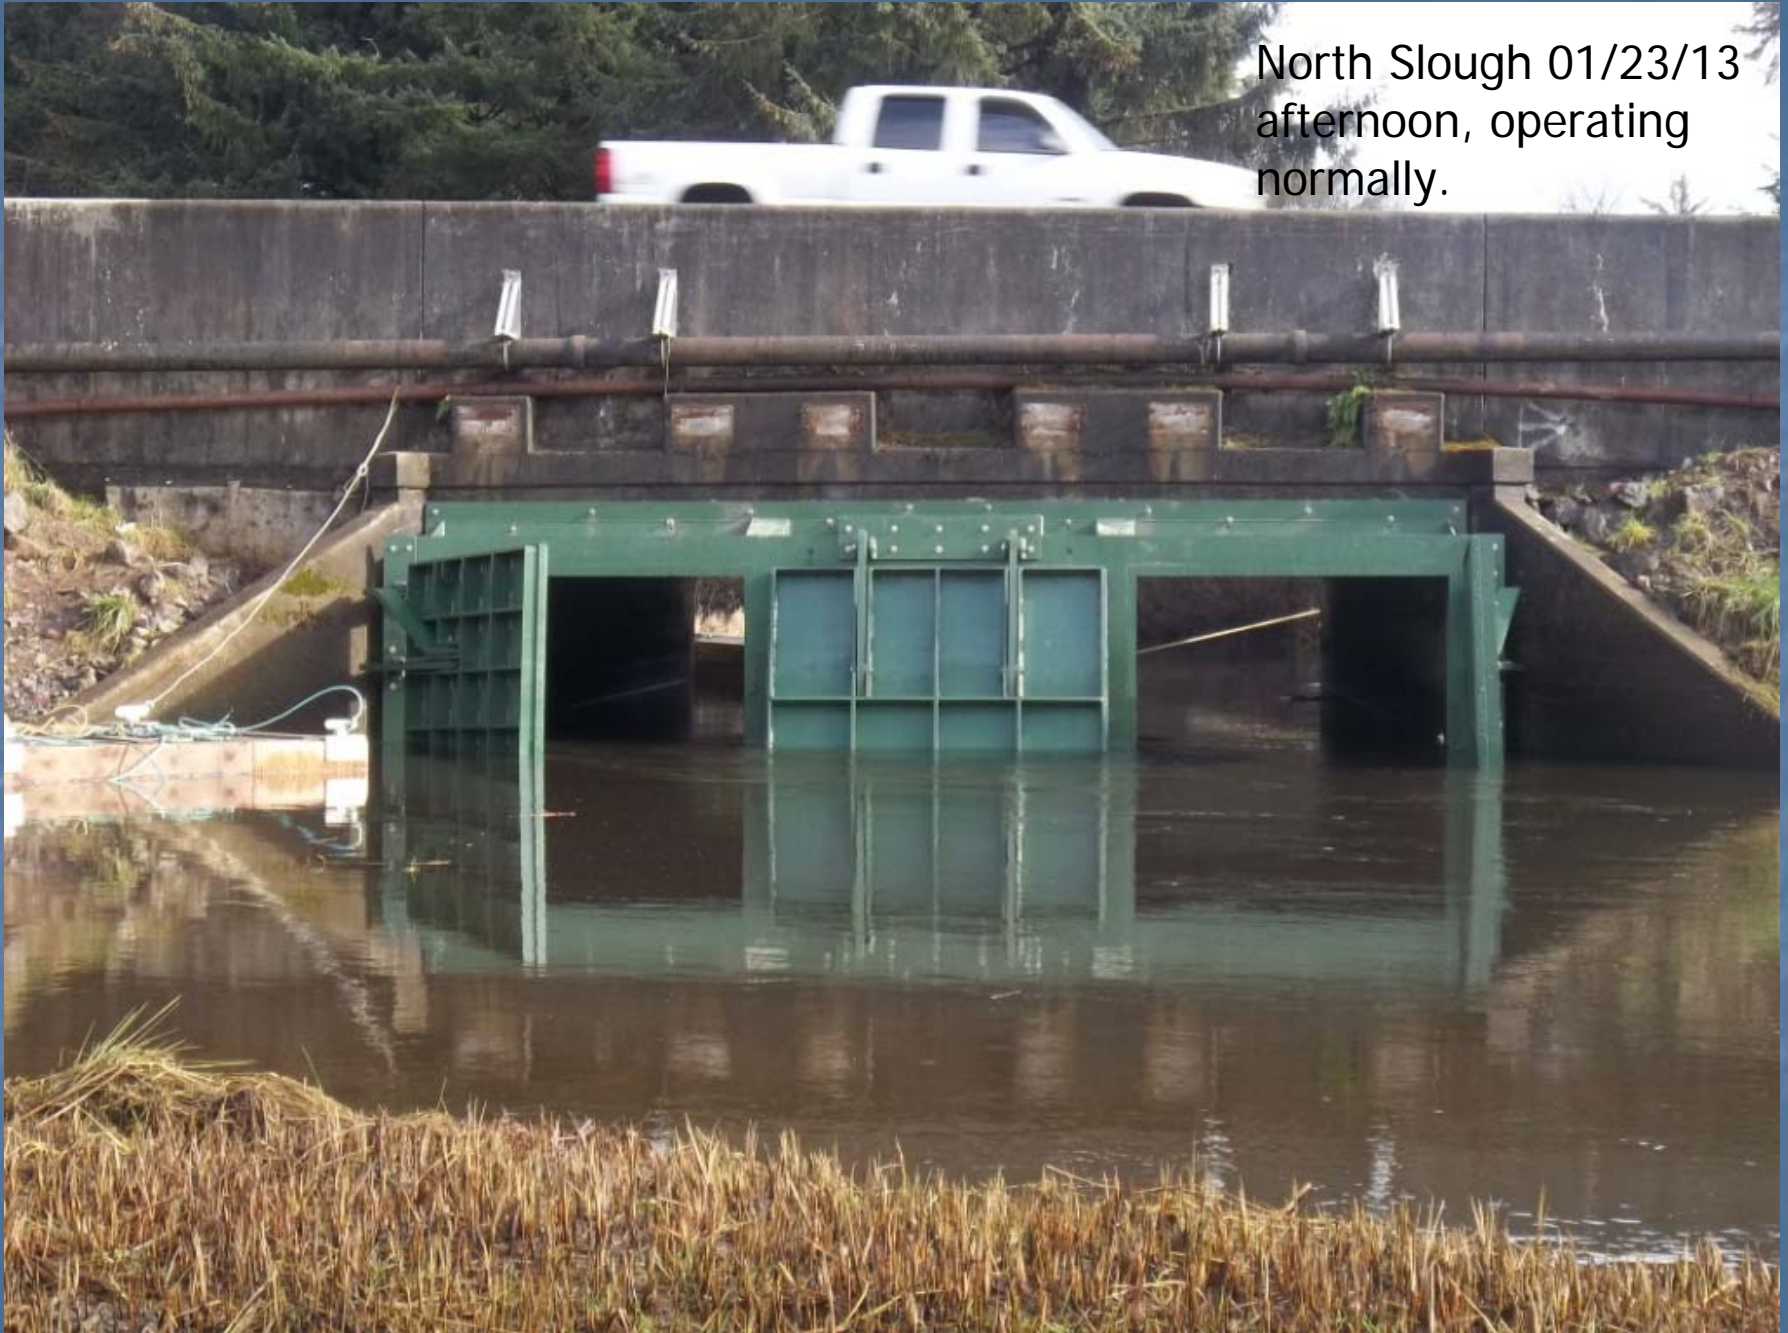
A typical 4' side-hinge tidegate
"ready to install" unit.

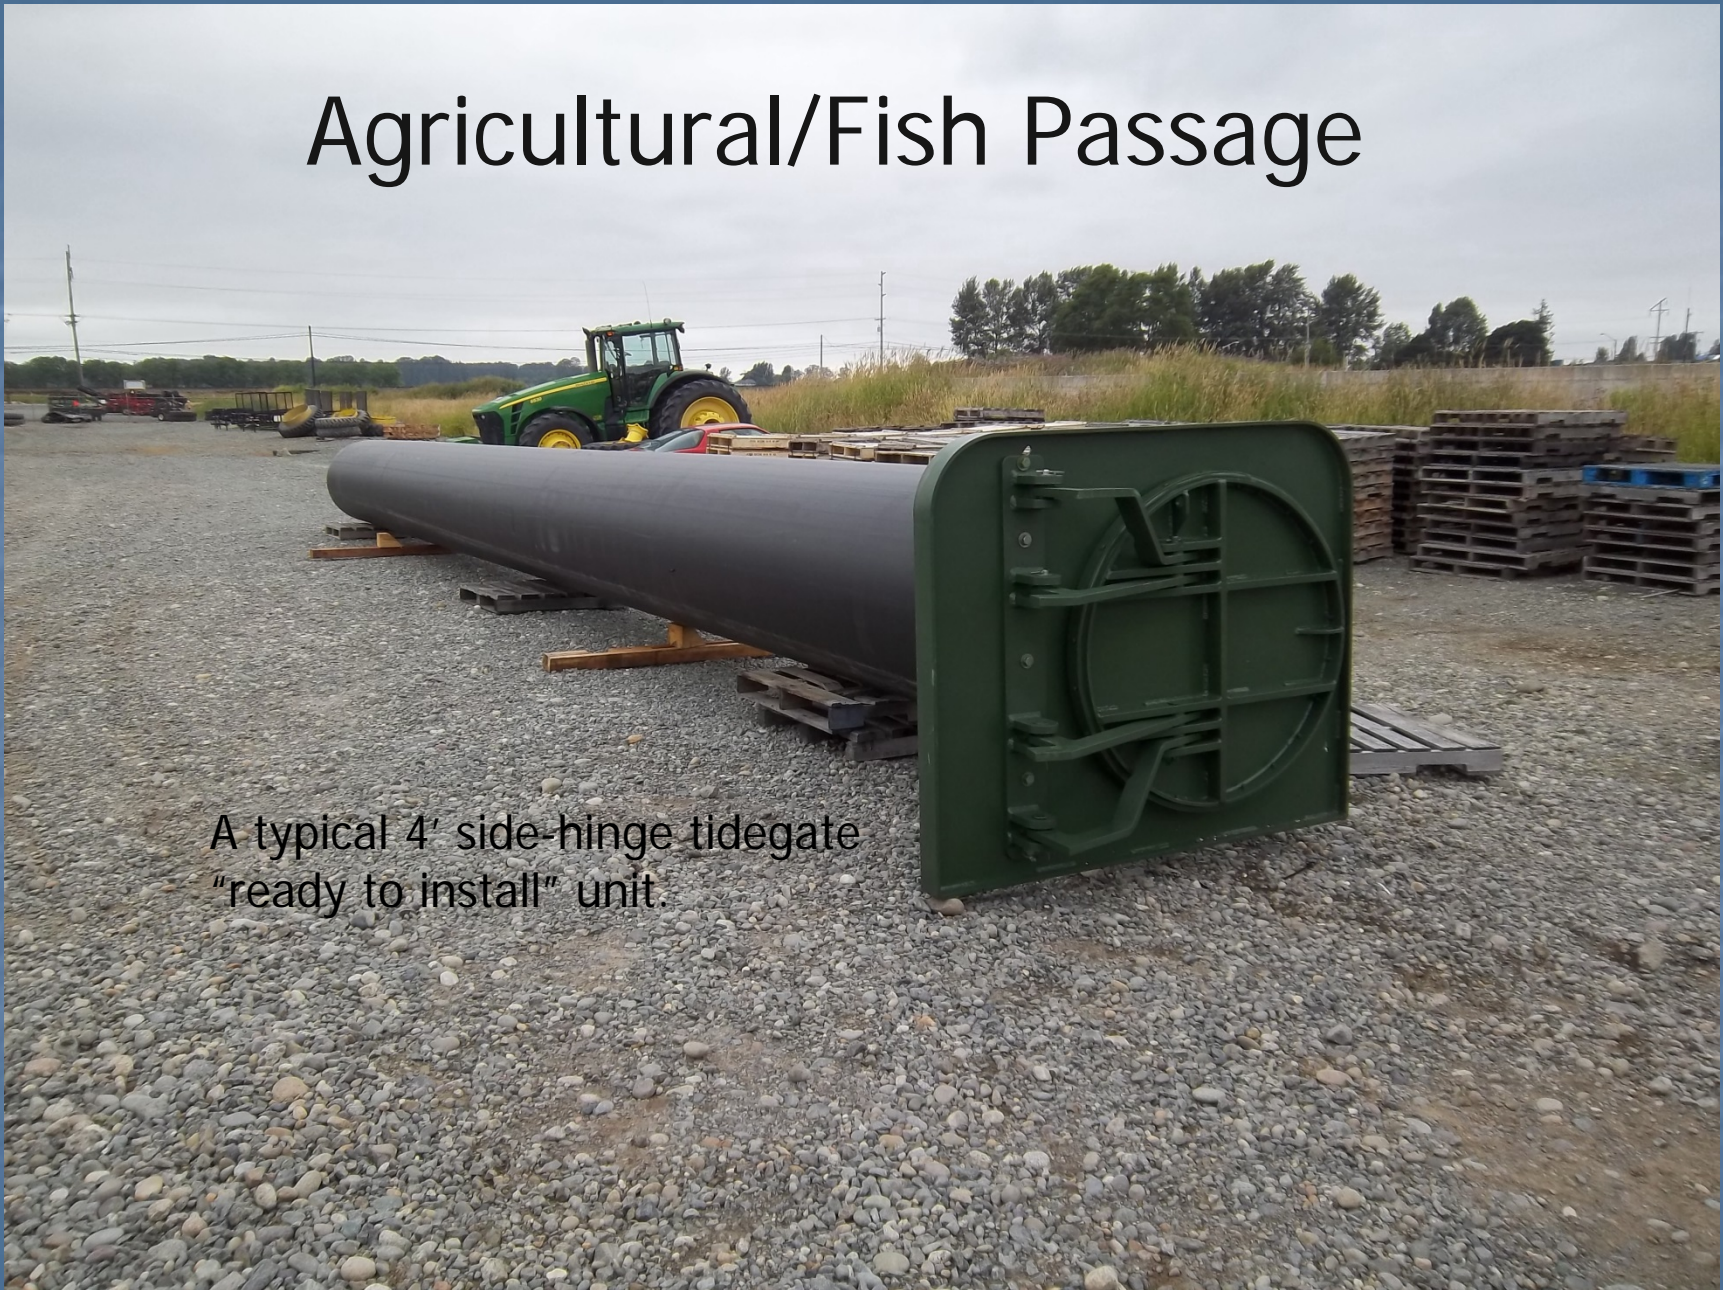
Typical 4' side-hinge
tidegate unit
installed.

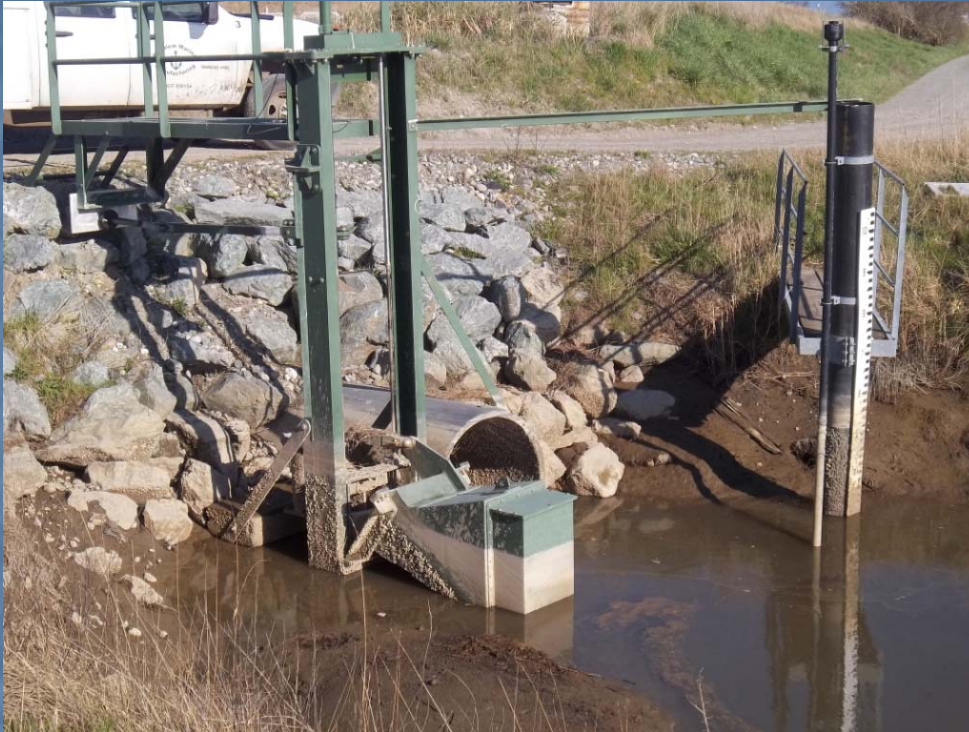
Fornsby Slough

Tidegate & MTR system at slack low-Tide.

Small note: Failed culverts and SRT have been replaced with sidehinge gate and MTR, mark on bank at target inundation level

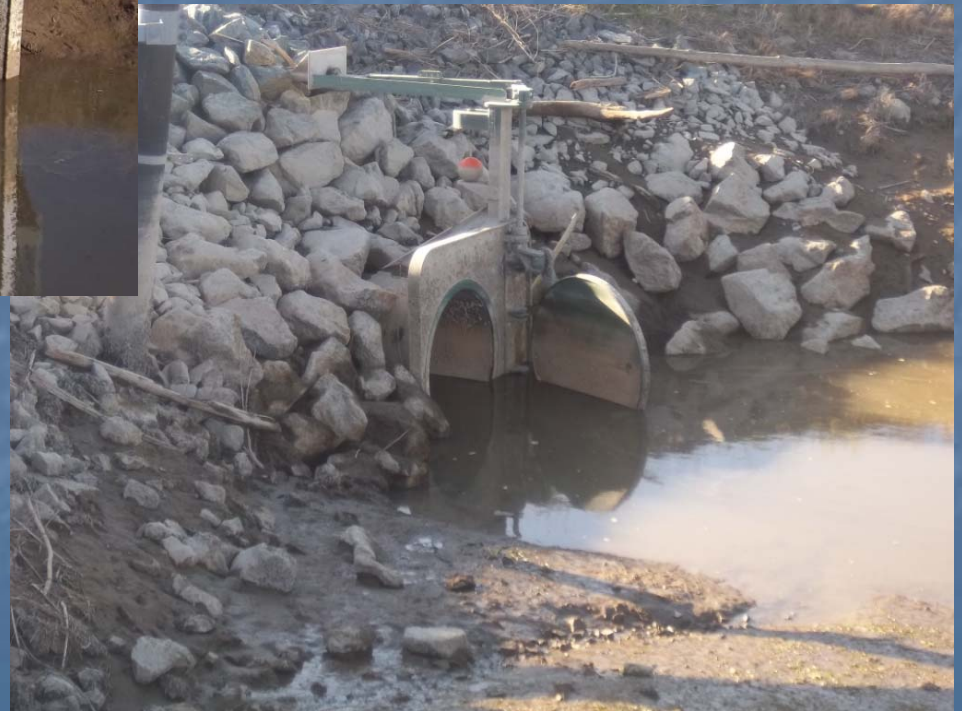
Target
inundation
level.

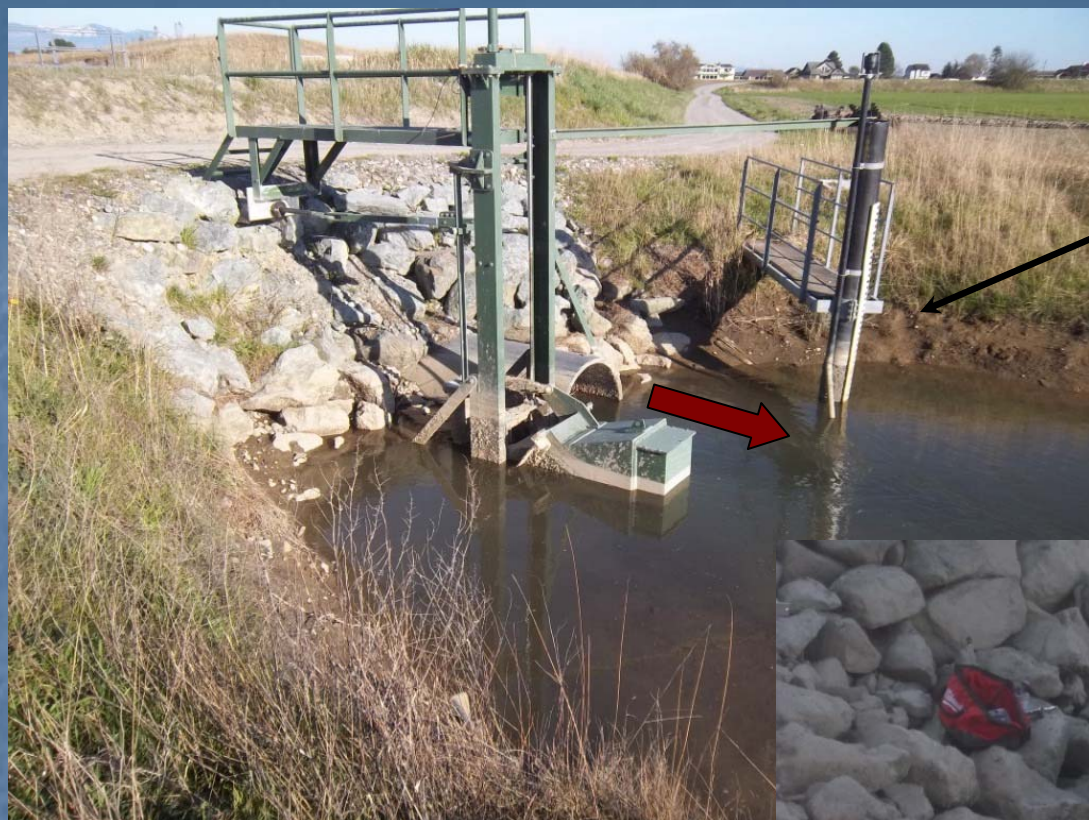
Tide flooding in.

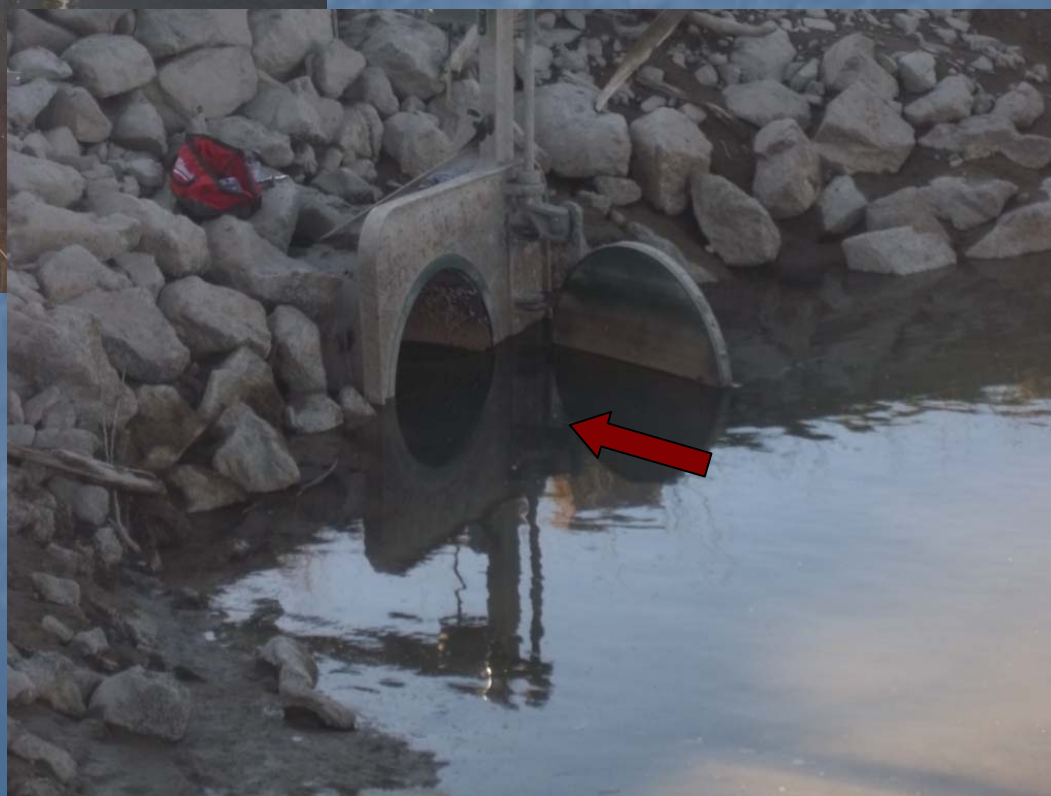
Nearing inundation level.

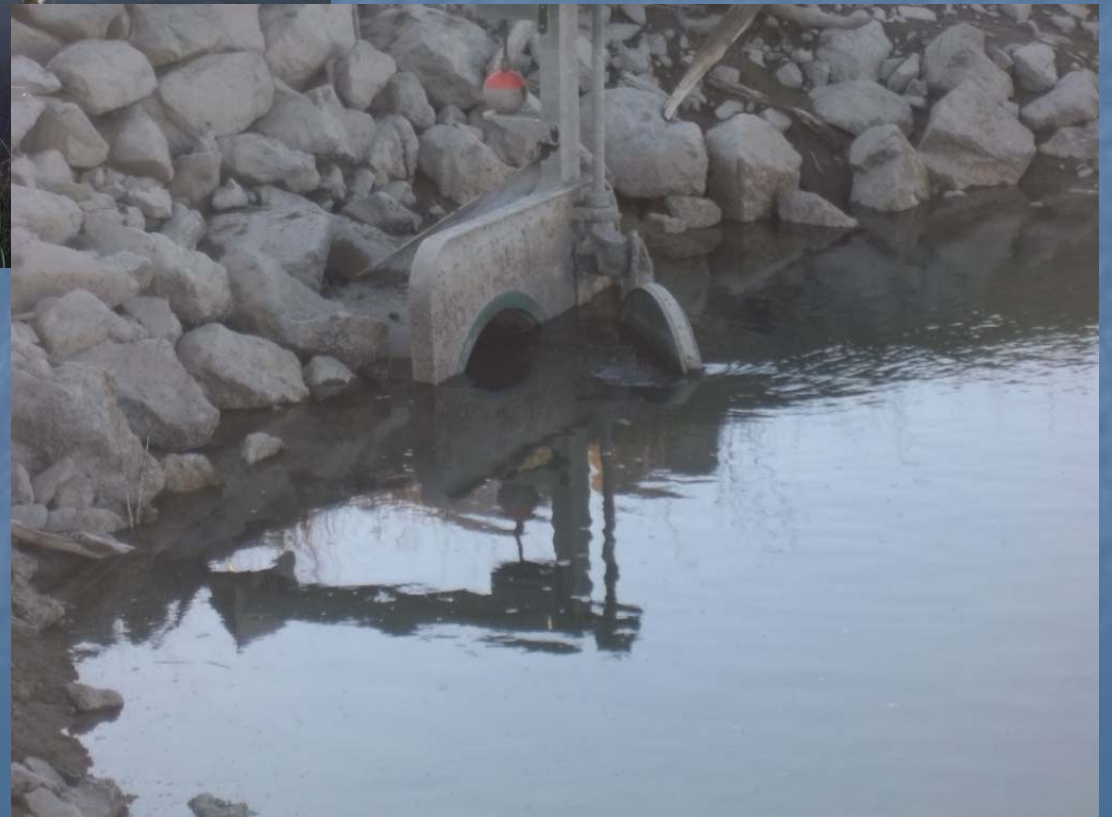
Tidegate closing.

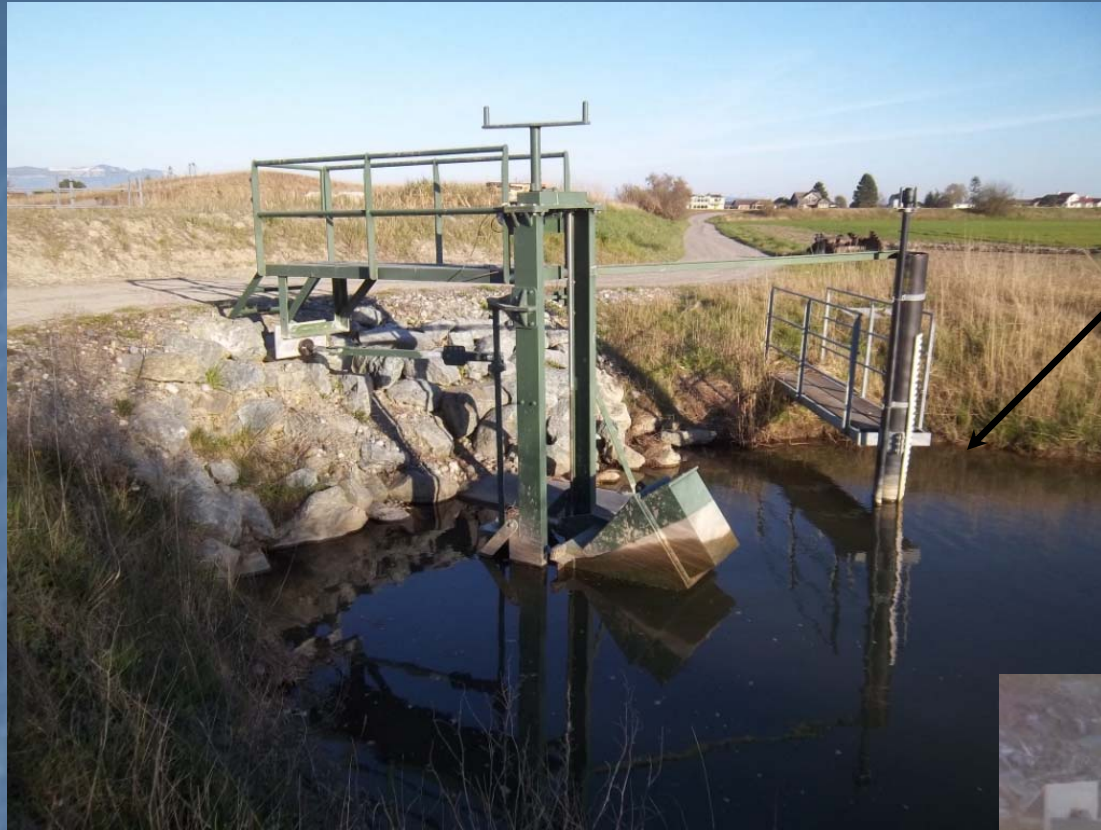
Tidegate MTR system at full Inundation level.

Note: The high-value agricultural land in the back ground.

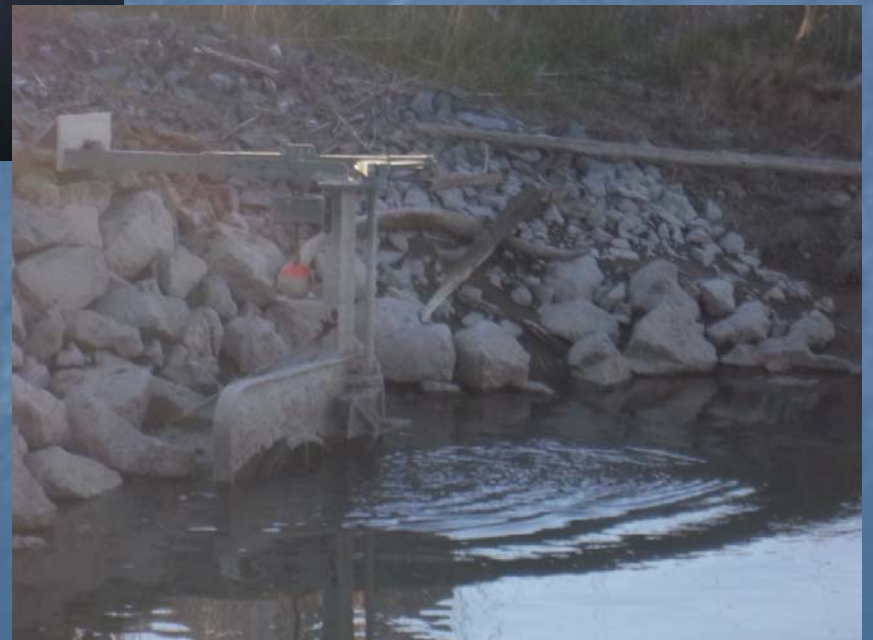
Tidegate closed.
